# Stream Mapping Results Report

## Trent River 2025

Prepared for the Beaufort Watershed Stewards.

*December 2025*

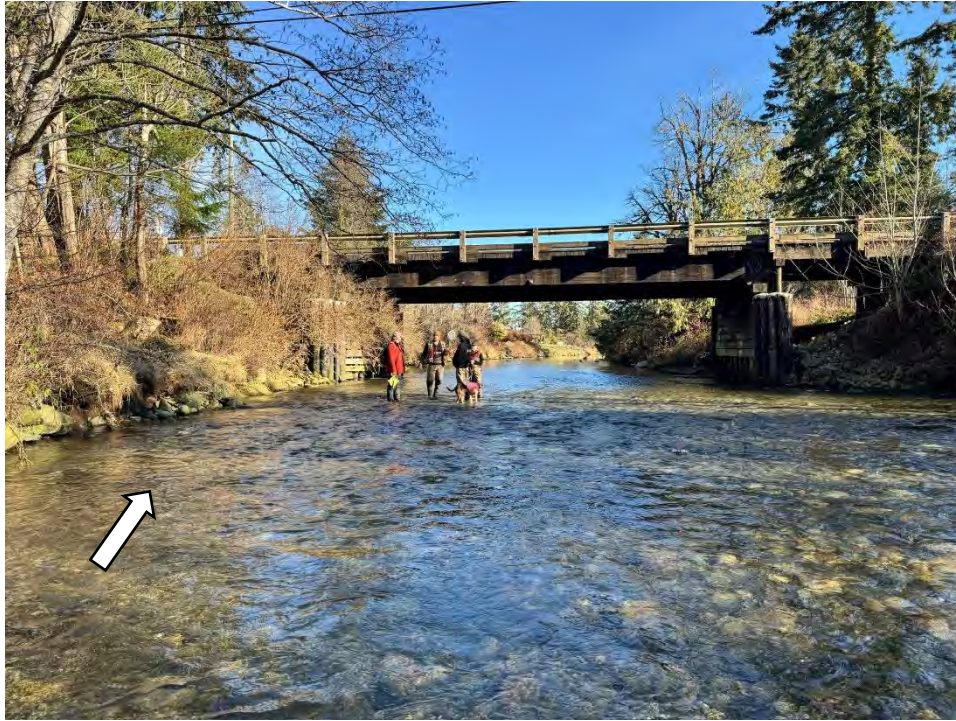
**Photo 1. Bridge at Hwy 19A. Arrow indicates flow direction. Photograph collected March 6, 2024.**

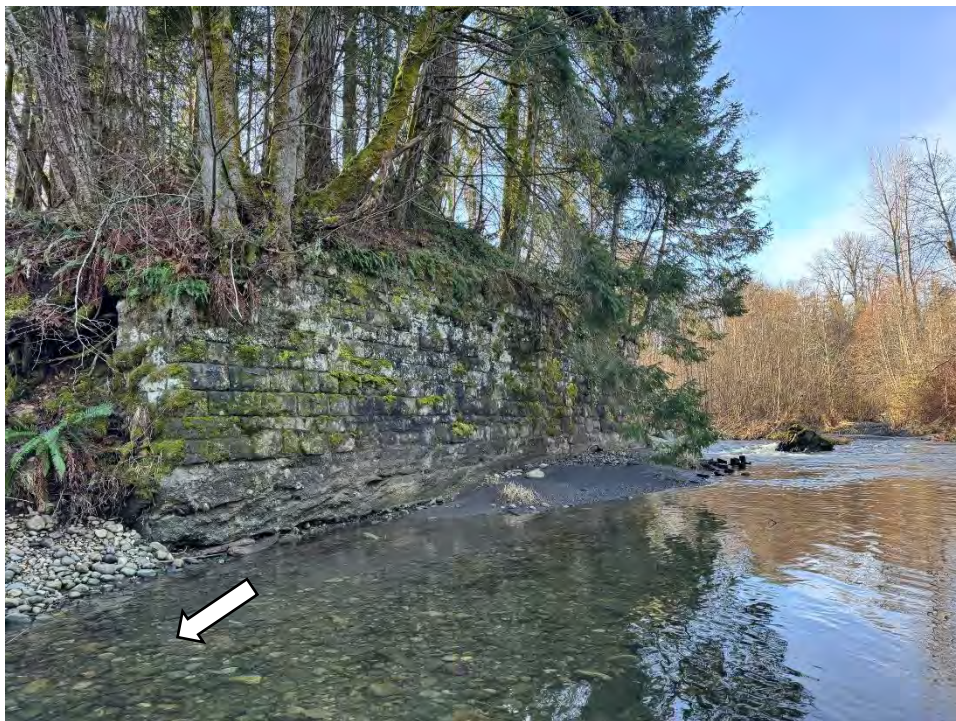
**Photo 2. Concrete footings of historic railway bridge. Arrow indicates flow direction. Photograph collected March 6, 2025.**

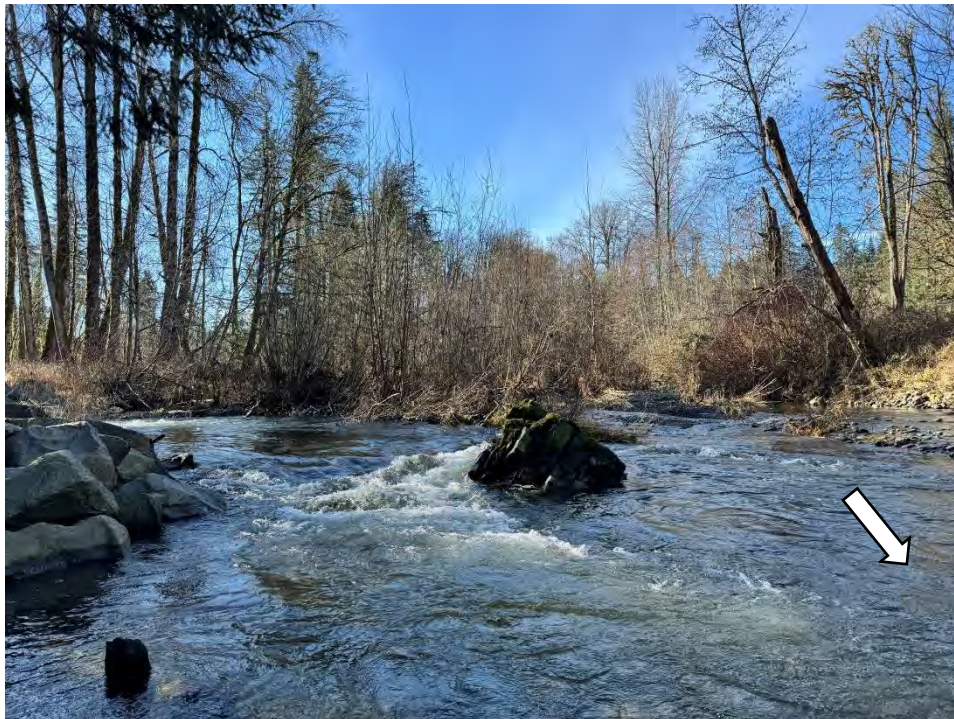
**Photo 3. Start of vegetated gravel bars upstream of old island highway (HWY 19A) bridge. Arrow indicates flow direction. Photograph collected March 6, 2025.**

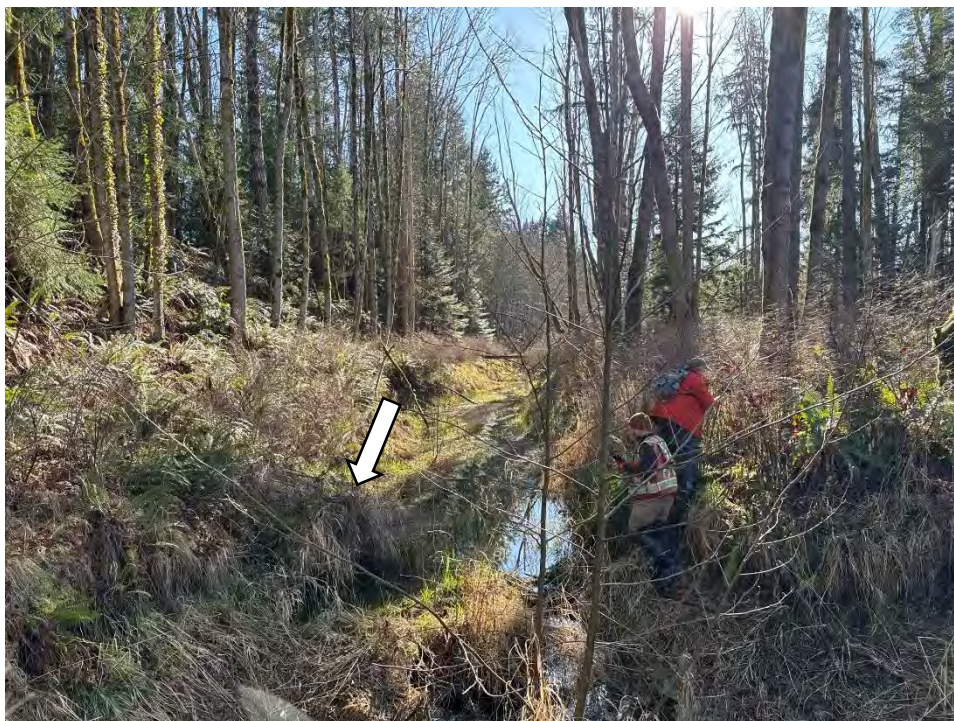
**Photo 4. Downstream outlet of a constructed river-right side channel (constructed by DFO). Arrow indicates flow direction. Photograph collected March 6, 2025.**

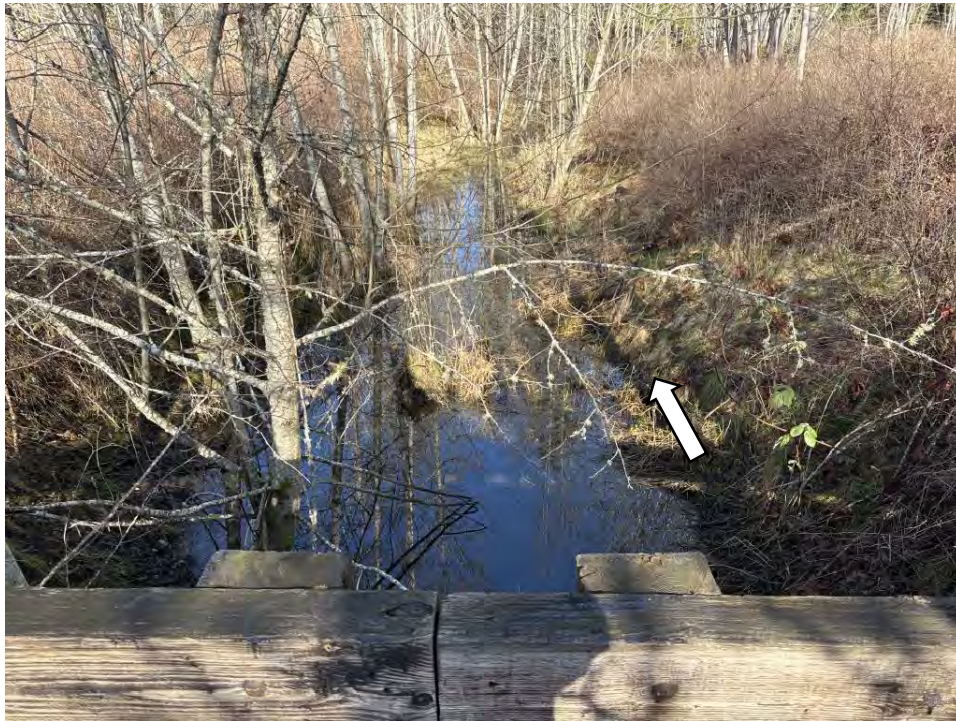
**Photo 5. Downstream view from bridge over the constructed river-right side channel (constructed by DFO). Arrow indicates flow direction. Photograph collected March 6, 2025.**

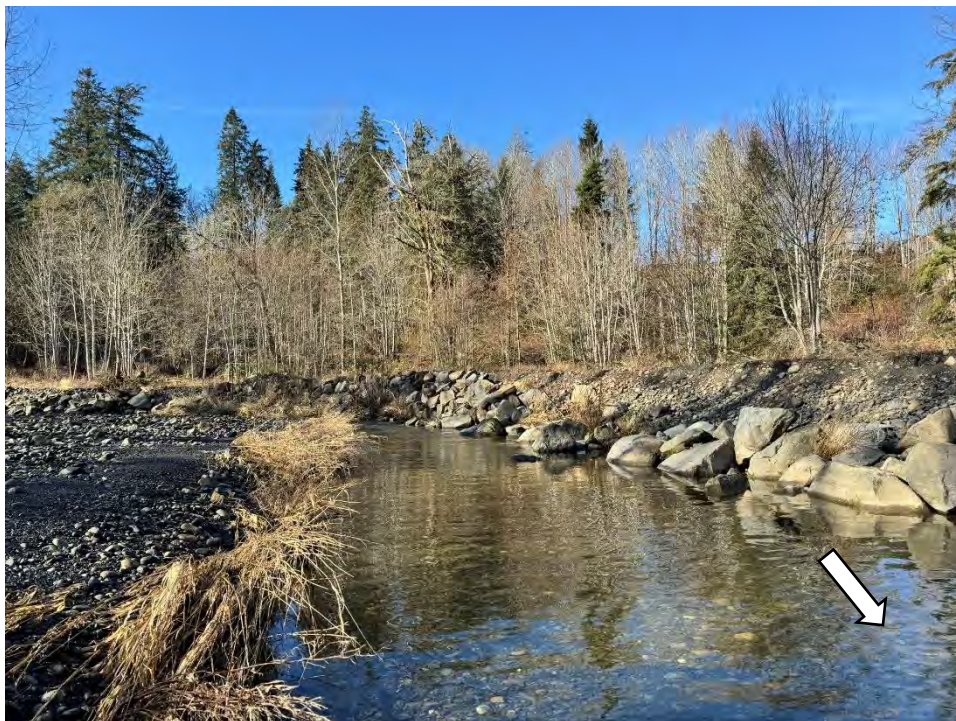
**Photo 6. Placed riprap along the river-left side channel. Arrow indicates flow direction. Photograph collected March 6, 2025.**

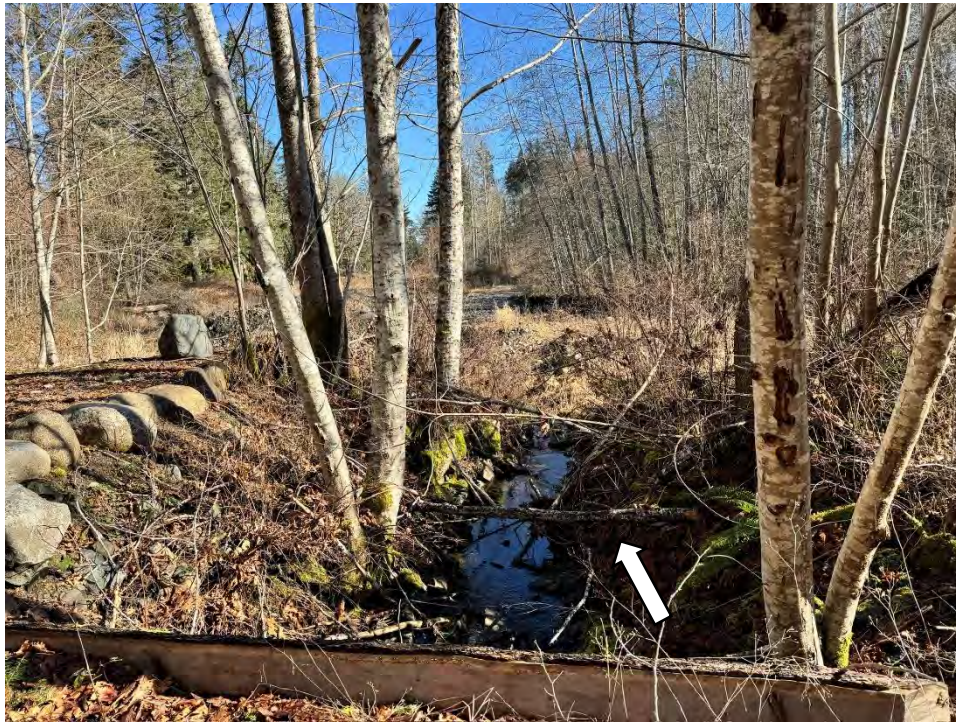
**Photo 7. Identified river-left tributary upstream of the placed riprap. A pedestrian bridge and walkway has been constructed over the channel. Arrow indicates flow direction. Photograph collected March 6, 2025.**

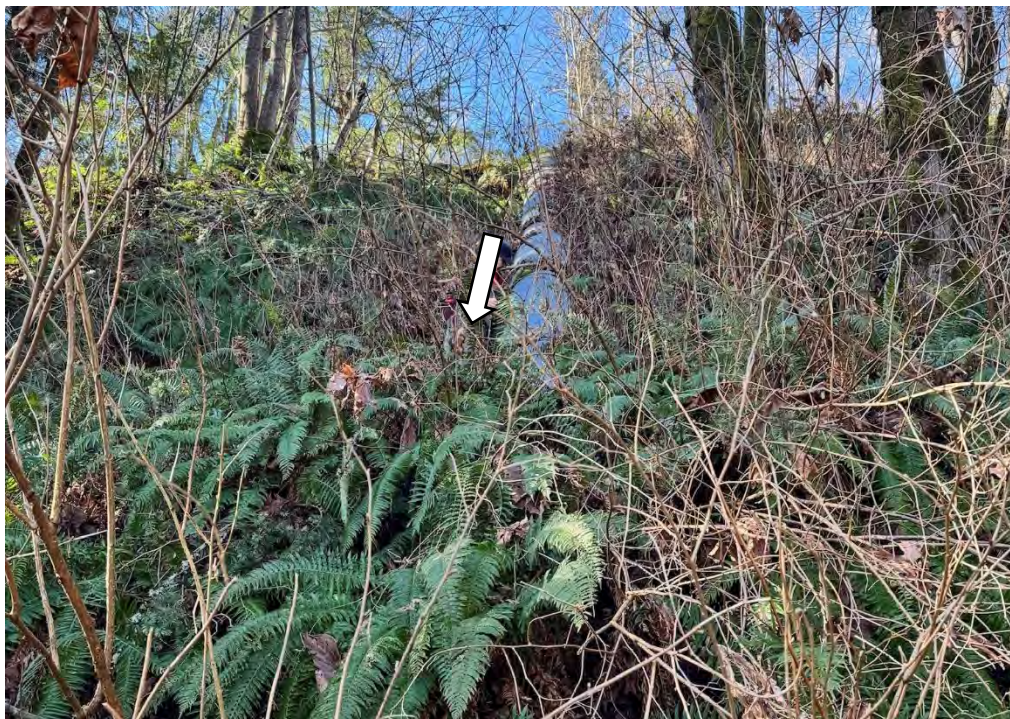
**Photo 8. Identified river-left tributary culvert upstream of the walkway. The top of the culvert originates at the railway. Arrow indicates flow direction. Photograph collected March 6, 2025.**

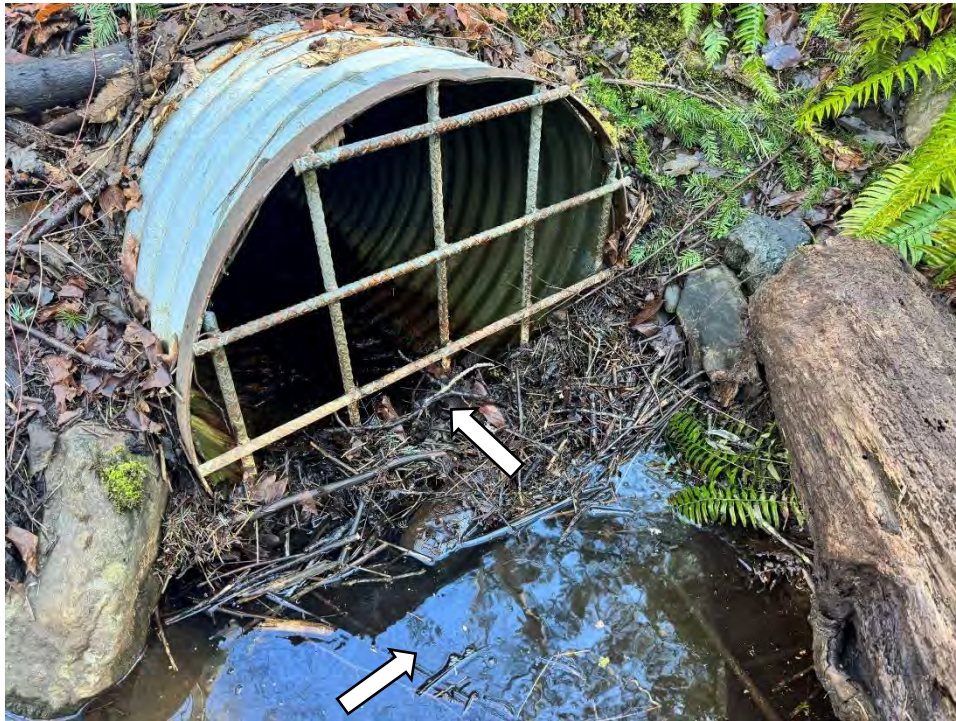
**Photo 9. Identified river-left tributary culvert inflow. Arrow indicates flow direction. Photograph collected March 6, 2025.**

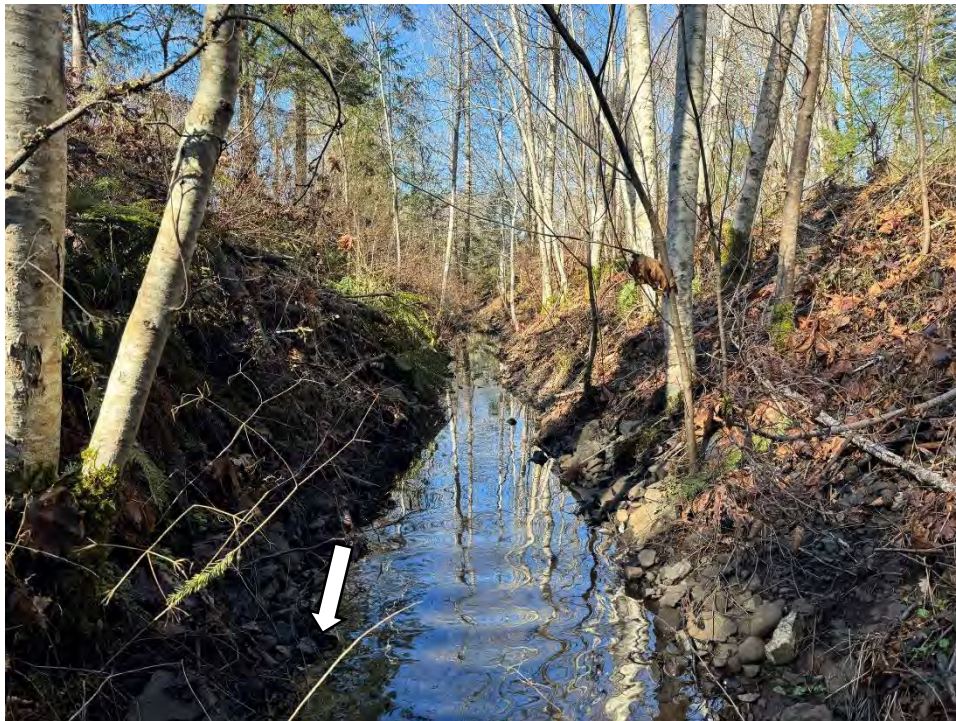
**Photo 10. Identified river-left tributary ditch along the railway. Arrow indicates flow direction. Photograph collected March 6, 2025.**

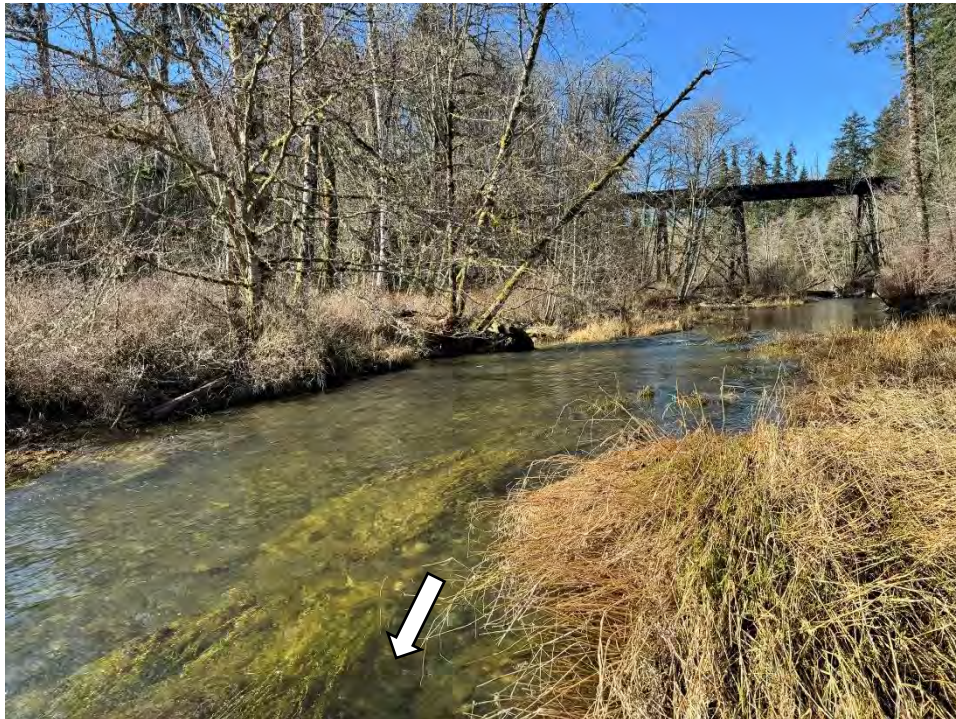
**Photo 11. View upstream at the railway trestle bridge over the Trent River mainstem. Arrow indicates flow direction. Photograph collected March 6, 2025.**

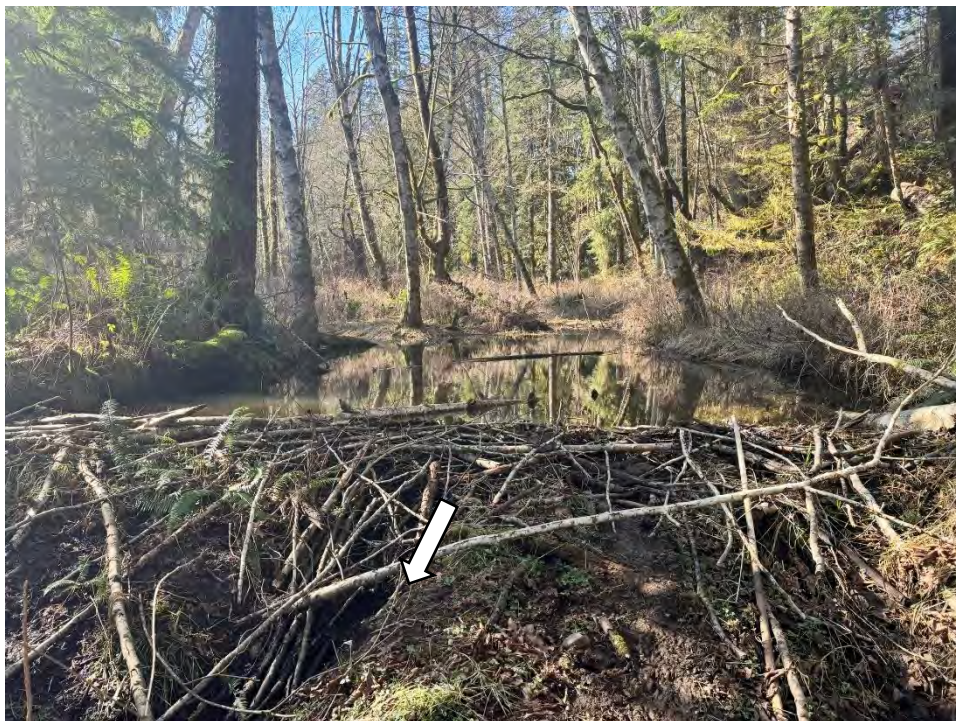
**Photo 12. Looking upstream at an active beaver dam creating river-left off-channel habitat above the trestle bridge. Arrow indicates flow direction. Photograph collected March 6, 2025.**

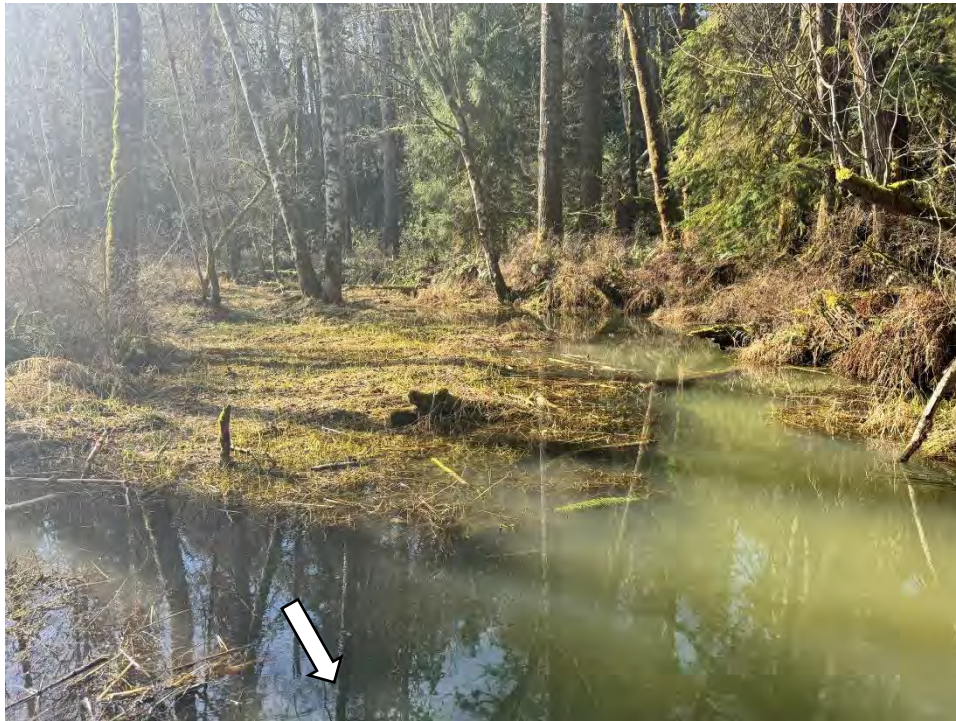
**Photo 13. View of the pond created by the beaver dam. Excellent off-channel habitat for juvenile salmonid rearing. Arrow indicates flow direction. Photograph collected March 6, 2025.**

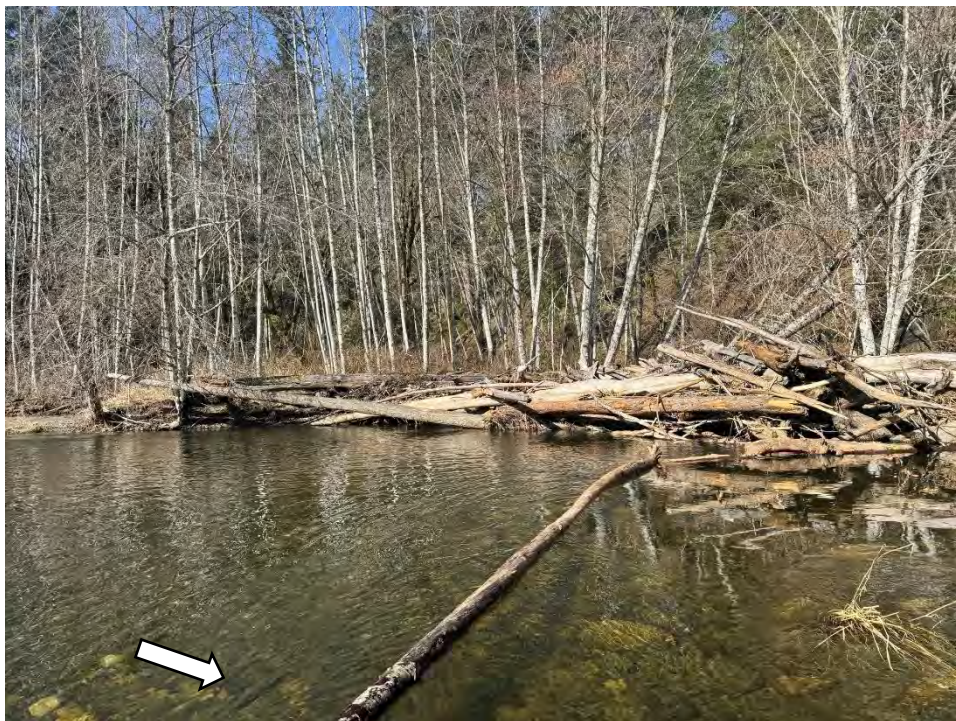
**Photo 14. View of a large LWD jam at the top of a river-left side channel. Arrow indicates flow direction. Photograph collected March 6, 2025.**

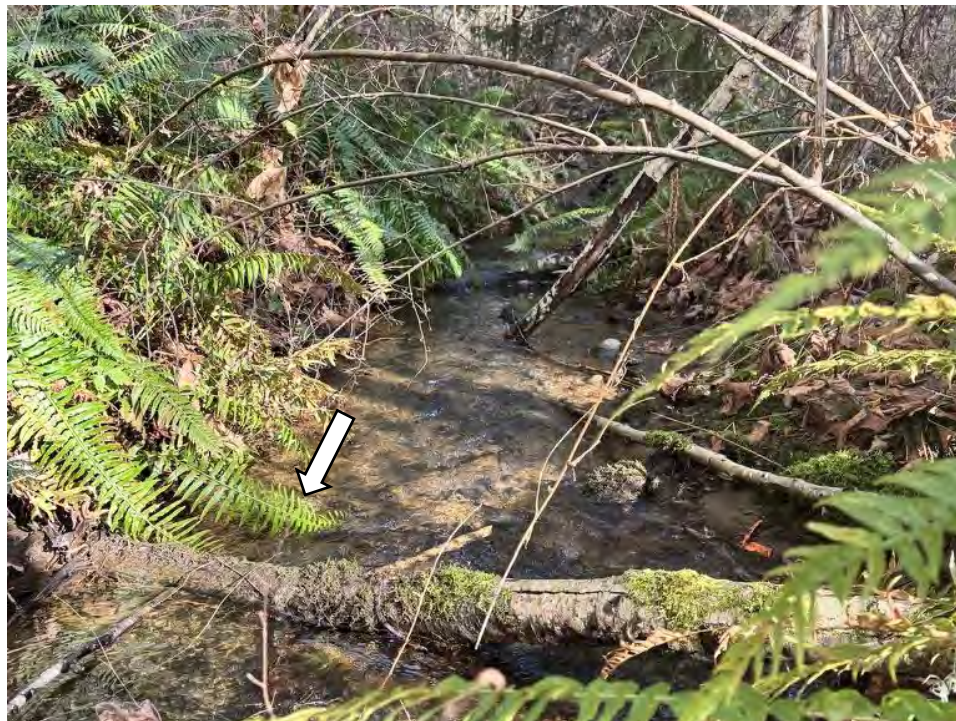
**Photo 15. View looking upstream at an identified river-left tributary. Arrow indicates flow direction. Photograph collected March 6, 2025.**

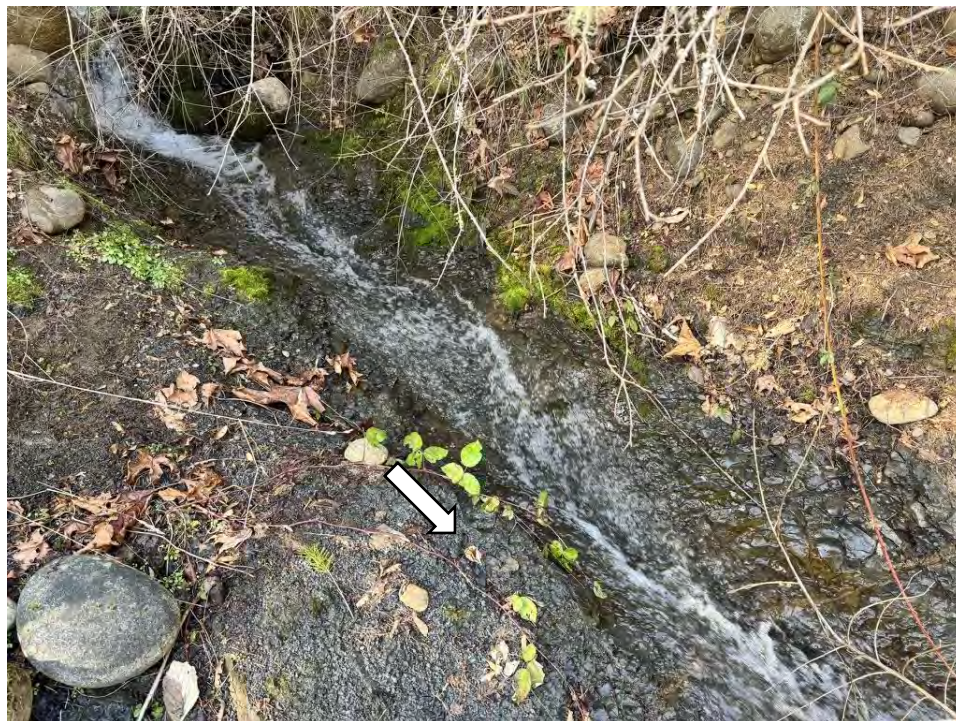
**Photo 16. View of the river-left tributary bedrock chute near the confluence with the mainstem. Arrow indicates flow direction. Photograph collected March 6, 2025.**

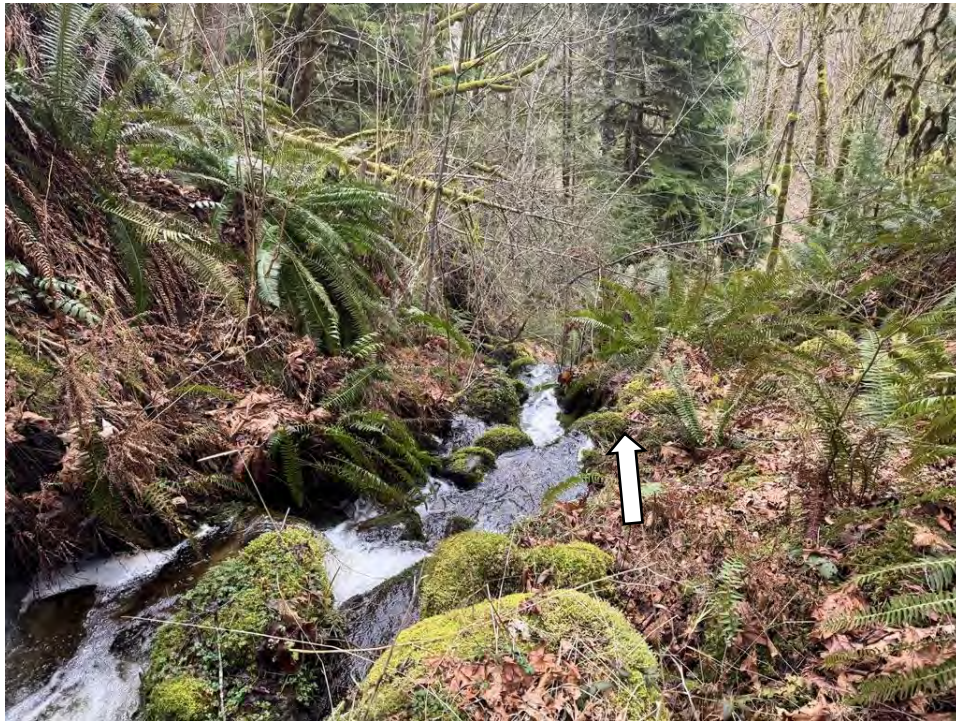
**Photo 17. View from the top of the river-left tributary falls. Arrow indicates flow direction. Photograph collected March 6, 2025.**

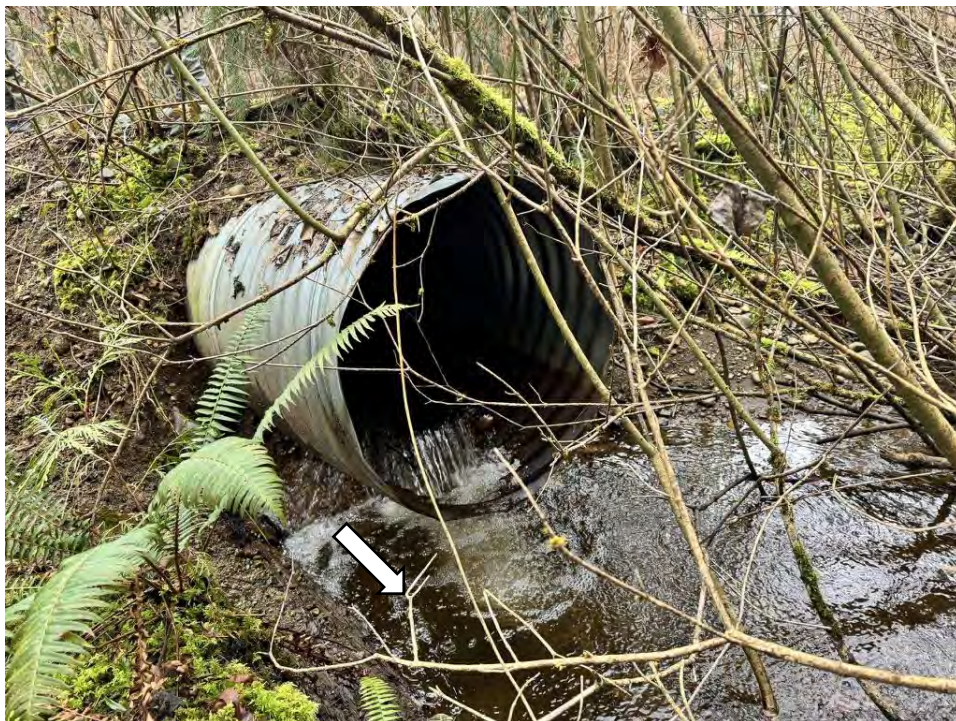
**Photo 18. View of the primary culvert under the start of the Royston to Cumberland Railway Trails. Arrow indicates flow direction. Photograph collected March 7, 2025.**

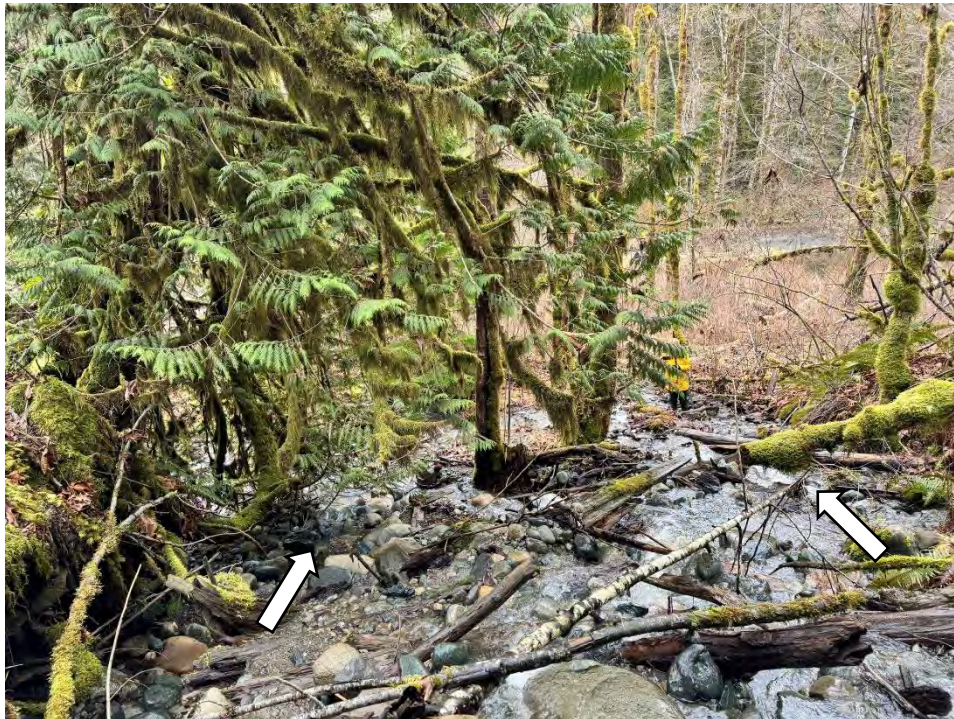
**Photo 19. View of the river-left tributary sourced from the above culvert. Evidence of a high-flow blowout. Arrows indicate flow direction. Photograph collected March 7, 2025.**

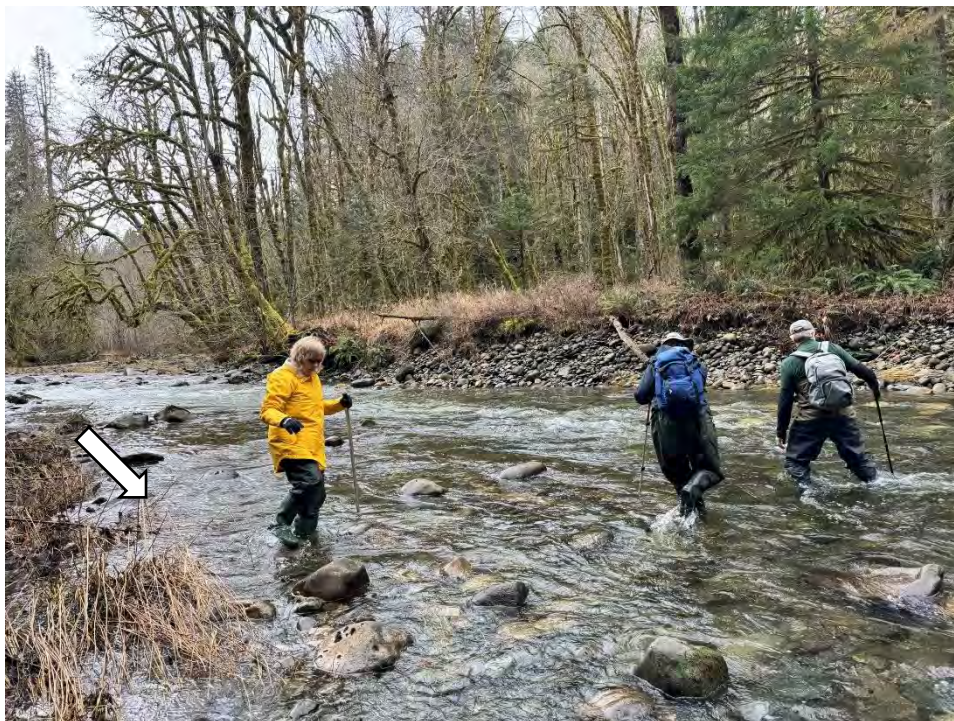
**Photo 20. Representative view of mainstem habitat. BWS volunteers traversing the river to the river-left bank. Arrow indicates flow direction. Photograph collected March 7, 2025.**

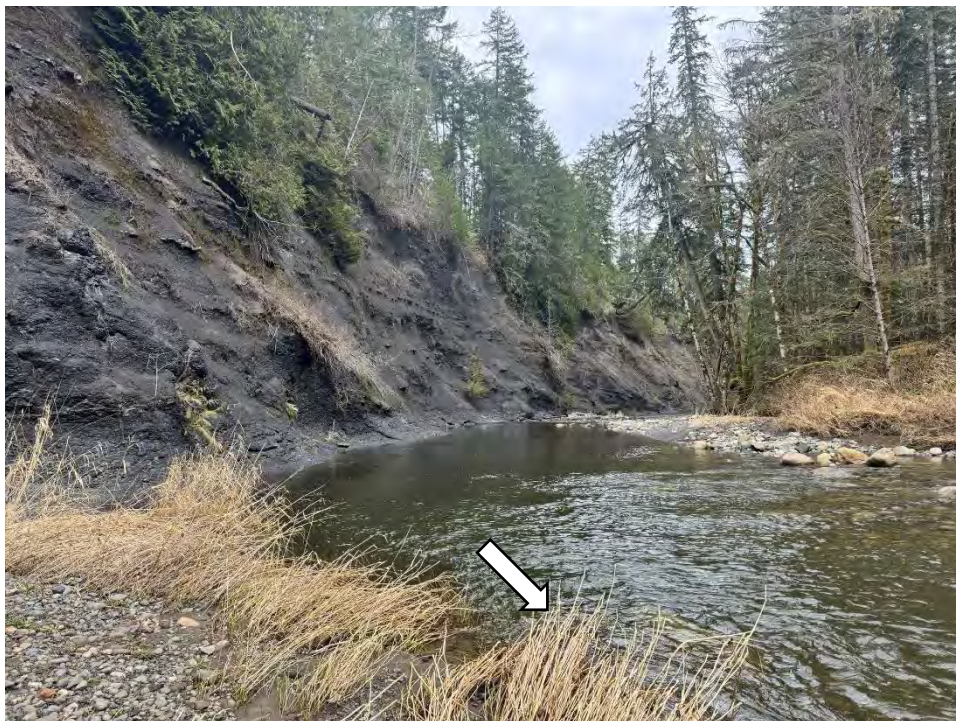
**Photo 22. Representative view of eroding shale cliffs (river-right) that define the Trent river above the trestle bridge. Arrow indicates flow direction. Photograph collected March 7, 2025.**

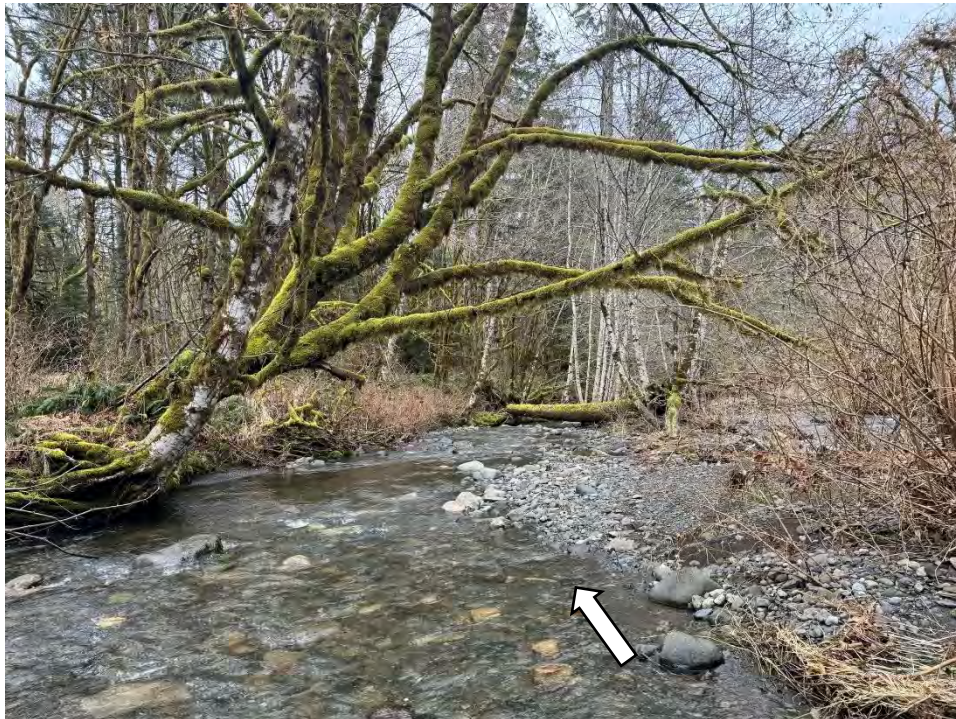
**Photo 23. Representative view of side channel habitat (river-left). Many coho fry and smolts were observed here. Arrow indicates flow direction. Photograph collected March 7, 2025.**

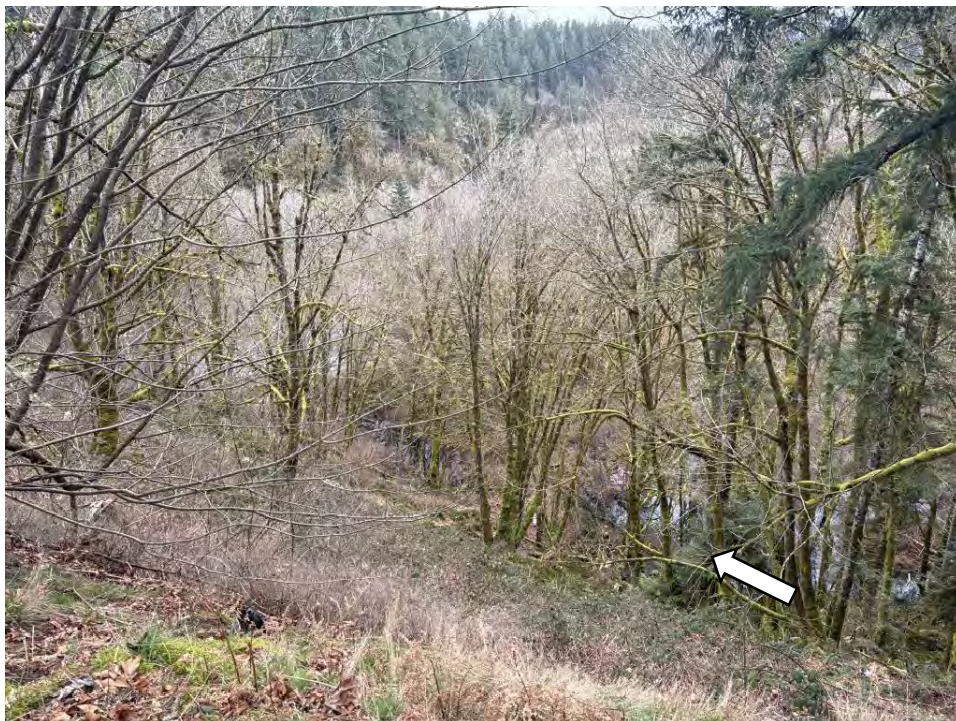
**Photo 24. River-left tributary sourced from beaver pond. Arrow indicates flow direction. Photograph collected March 7, 2025.**

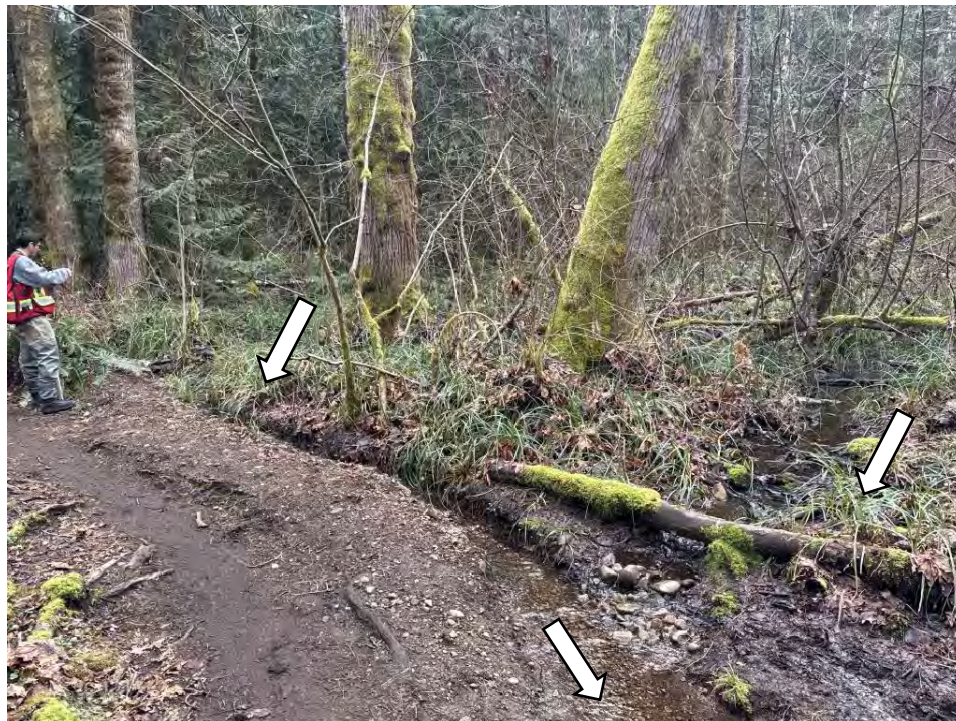
**Photo 25. River-left tributary (multiple channels) sourced from wetland flowing towards the beaver pond. Arrows indicate flow direction. Photograph collected March 7, 2025.**

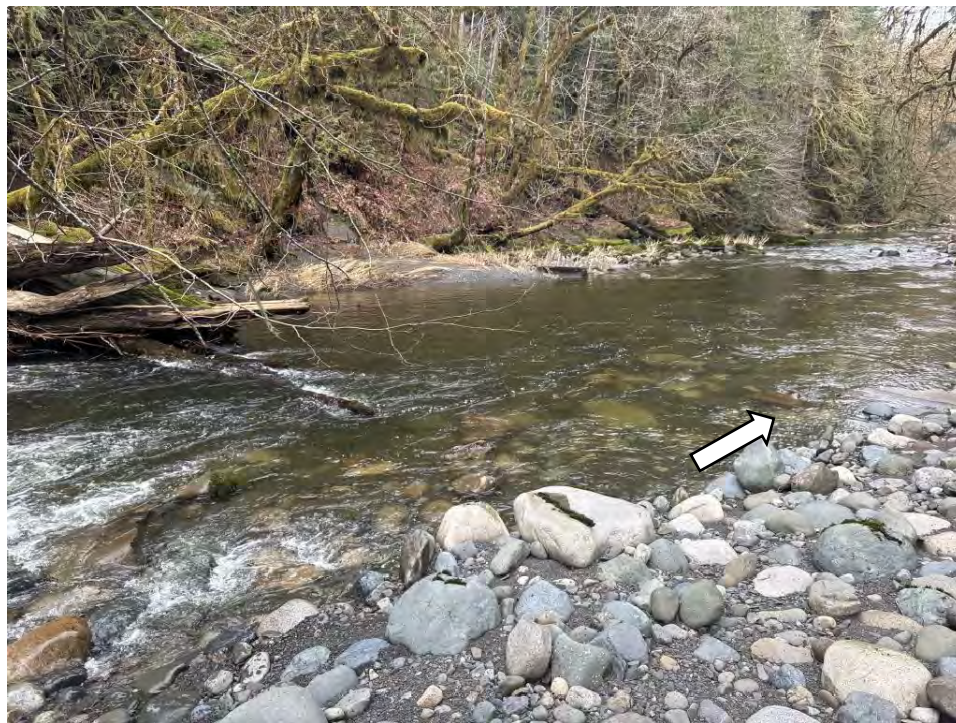
**Photo 26. View of a deep pool below large woody debris in the mainstem below the Hydro lines. Arrow indicates flow direction. Photograph collected March 7, 2025.**

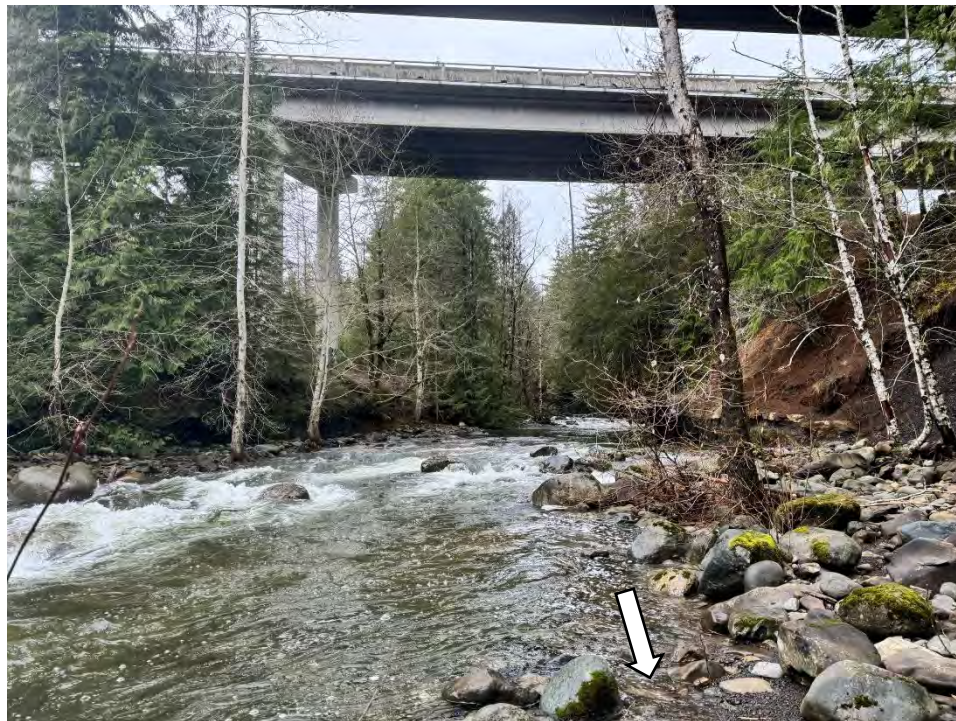
**Photo 27. Representative view of the mainstem below Hwy 19. Arrow indicates flow direction.  
Photograph collected March 10, 2025.**

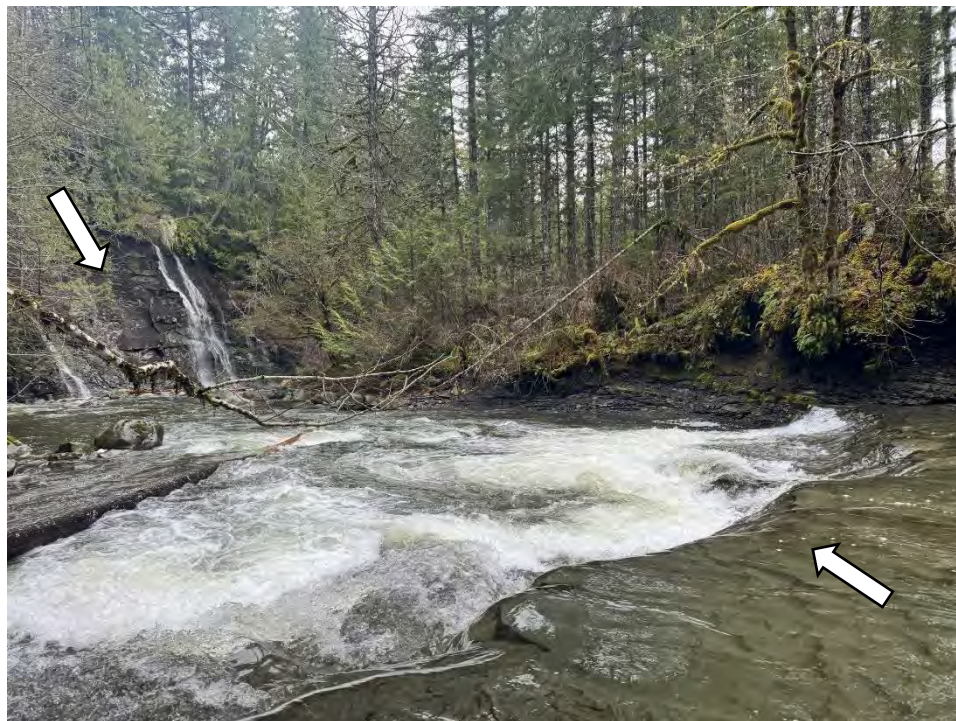
**Photo 28. View of the river-left tributary falls near Hwy 19. Arrows indicate flow direction.  
Photograph collected March 10, 2025.**

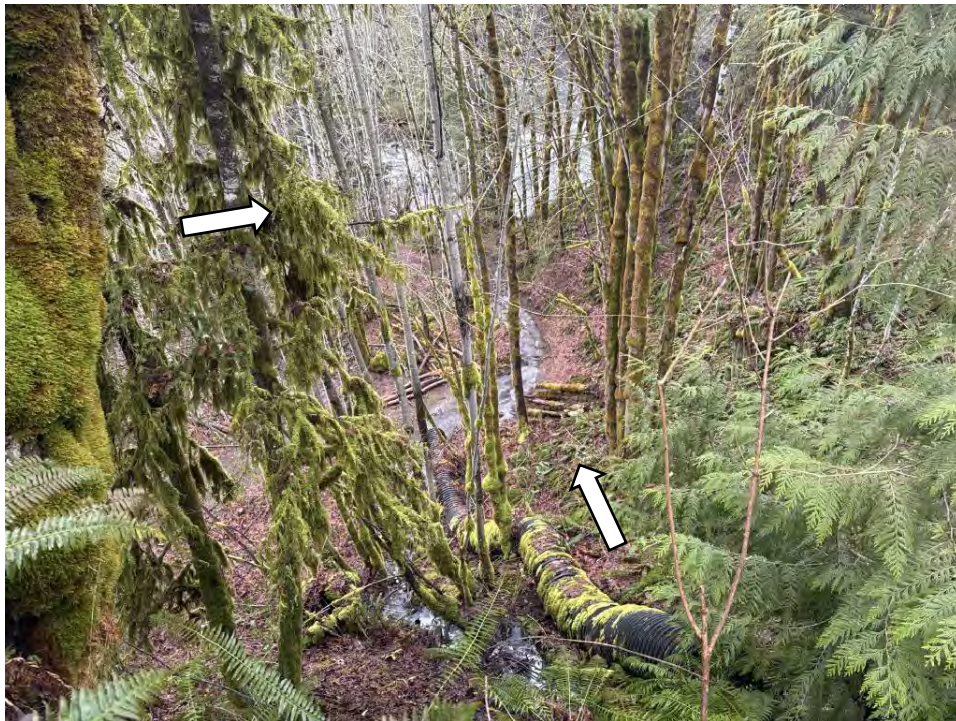
**Photo 29. River-right tributary below Hwy 19. Arrow indicates flow direction. Photograph collected March 10, 2025.**

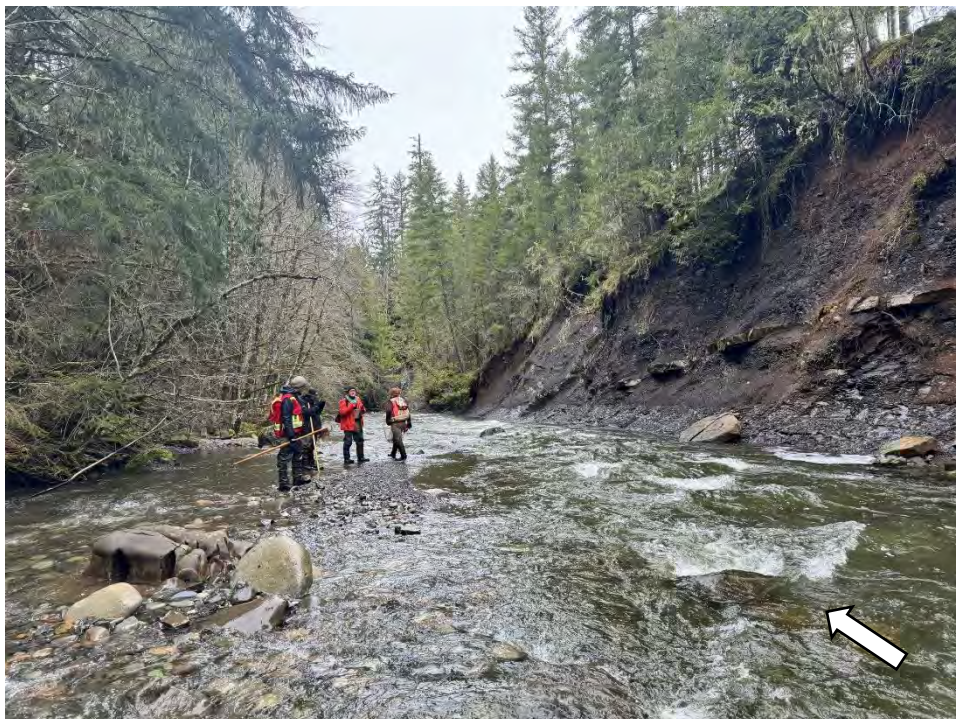
**Photo 30. Representative view of mainstem habitat above the Trent River falls. The KFN Guardians and BWS volunteers are assessing the river-right shale cliff. Arrow indicates flow direction. Photograph collected March 10, 2025.**

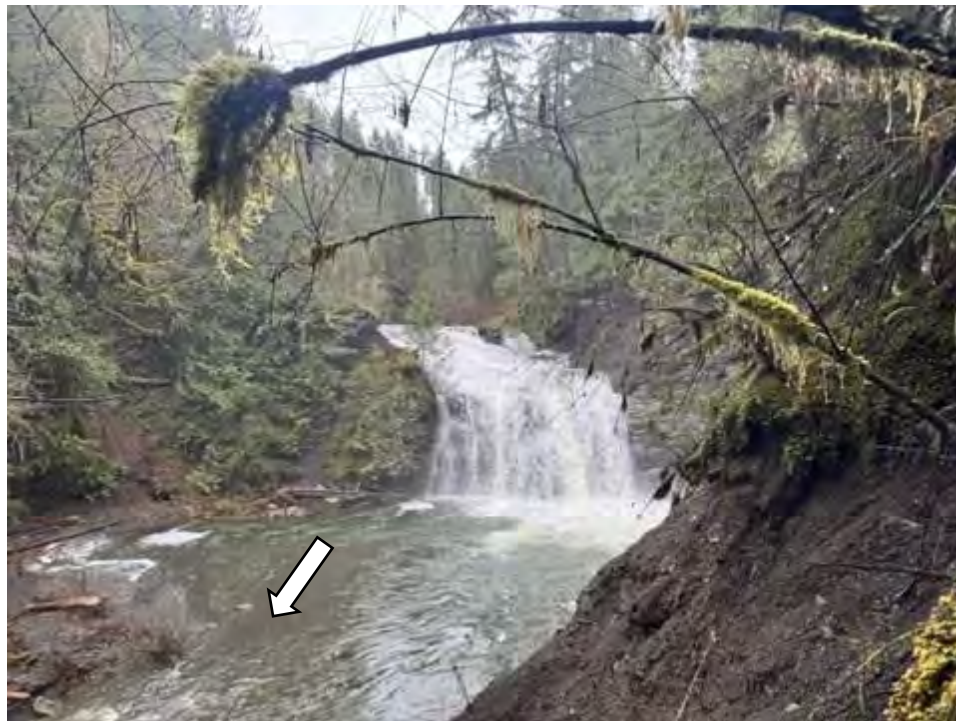
**Photo 31. Representative view of Trent River Falls. Resident trout were documented above the falls. Arrow indicates flow direction. Photograph collected March 10, 2025.**

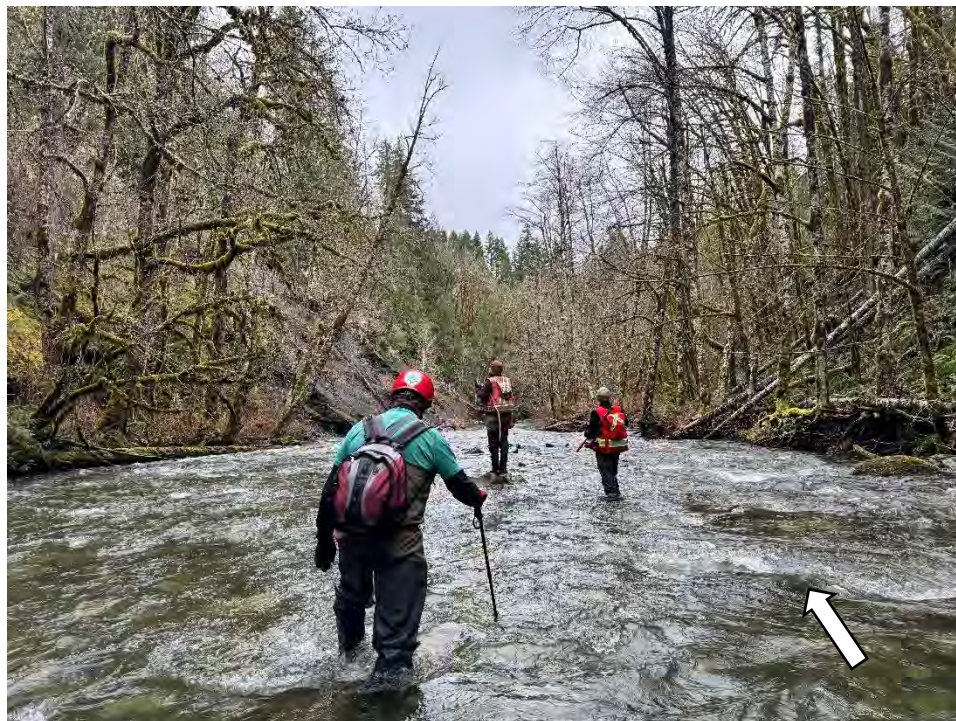
**Photo 32. KFN Guardians and BWS volunteer traversing the mainstem. Arrow indicates flow direction. Photograph collected March 10, 2025.**
