# Stream Mapping Results Report

## Trent River 2025

Prepared for the Beaufort Watershed Stewards.

*December 2025*

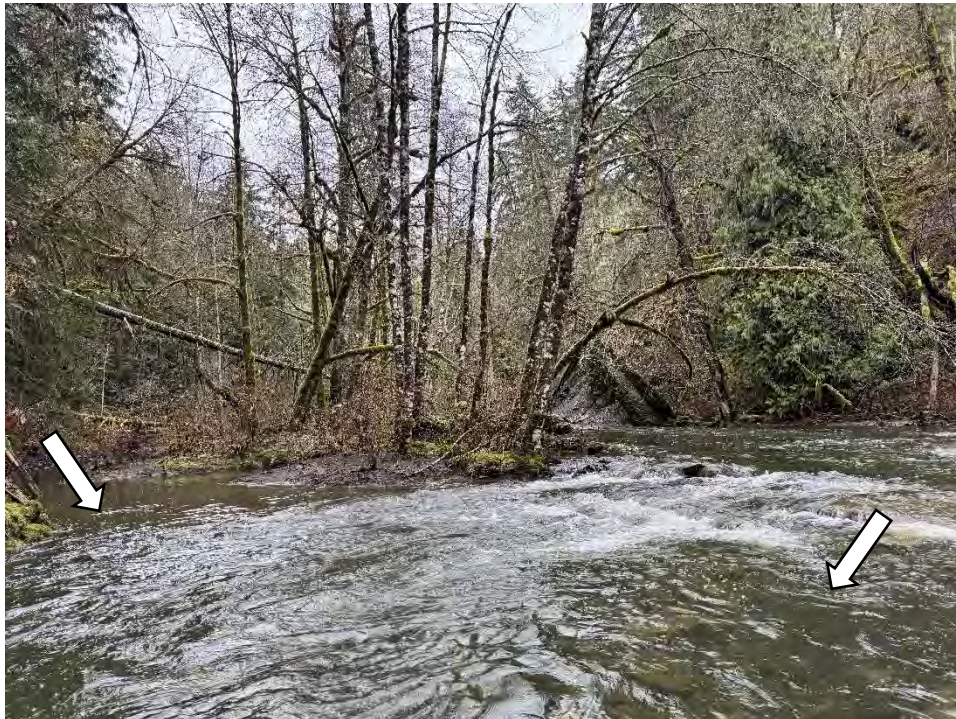
**Photo 33. Channels braiding around vegetated islands in the mainstem, creating side channel habitat. Arrows indicate flow direction. Photograph collected March 10, 2025.**

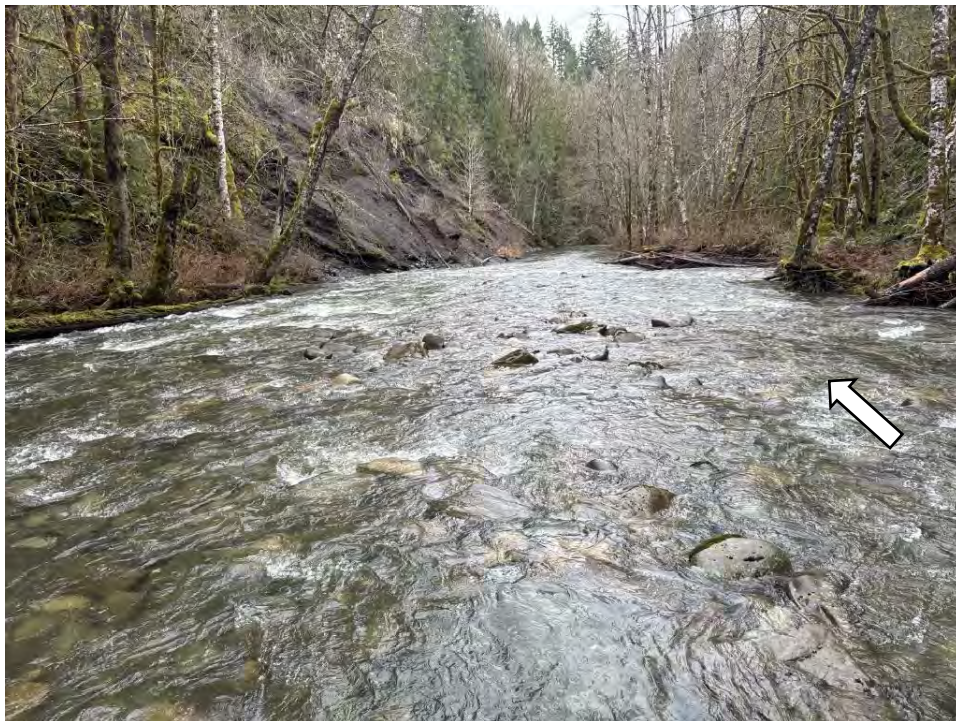
**Photo 34. Representative view of the mainstem below the Trent River Falls. Arrow indicates flow direction. Photograph collected March 10, 2025.**

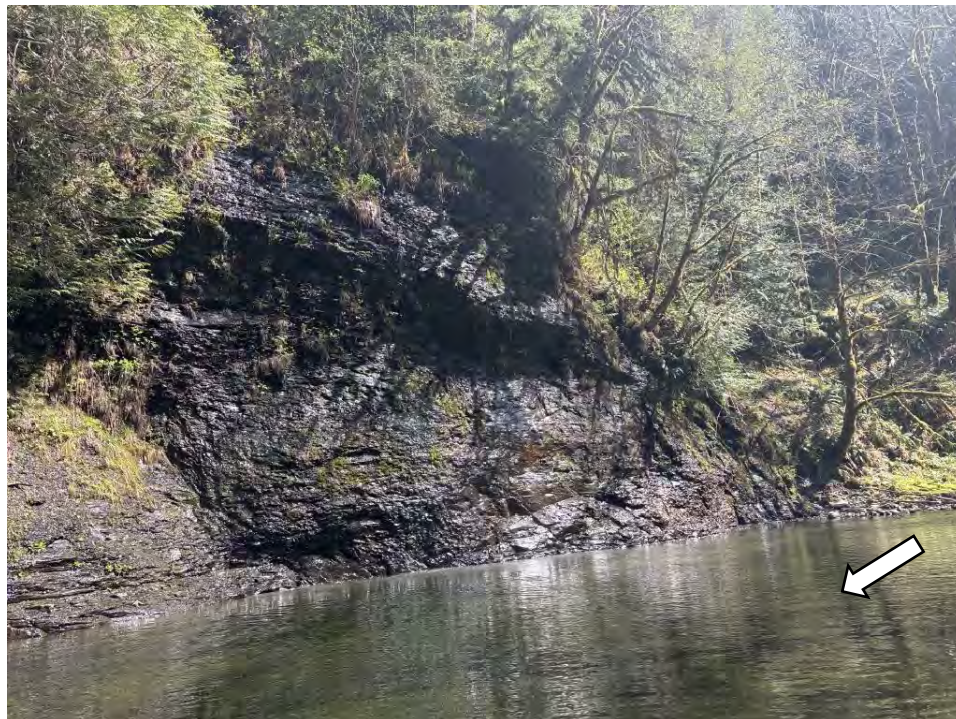
**Photo 35. River-right tributary seep sourced from Provincially mapped wetland (to be further assessed). Arrow indicates flow direction. Photograph collected April 24, 2025.**

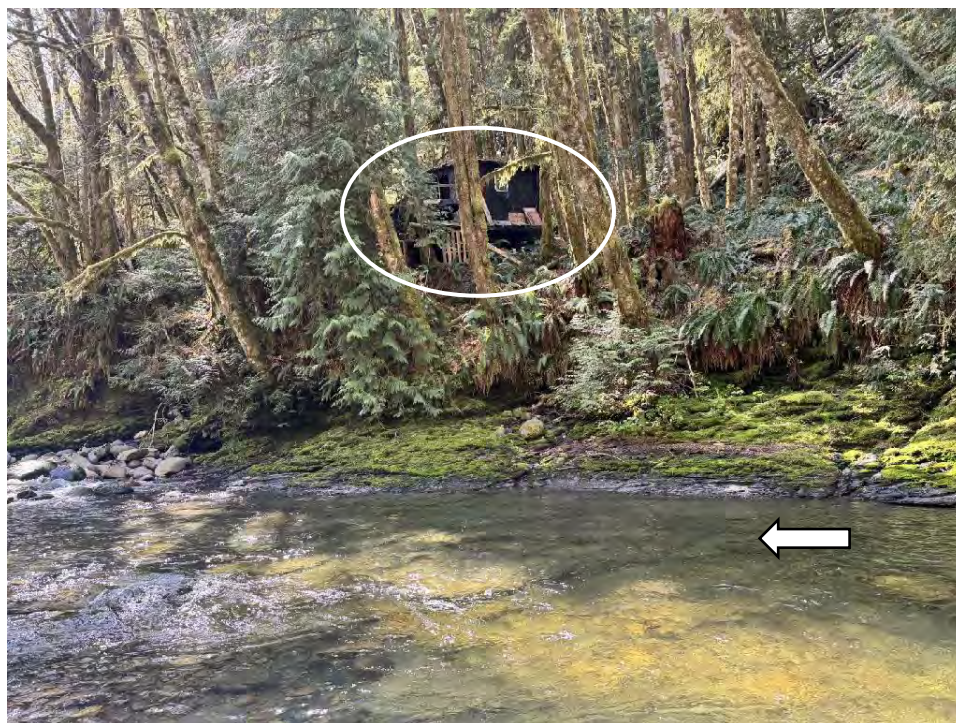
**Photo 36. Recreational use of the river-right bank along the mainstem, including a shack (circled) and ATV trail. Arrow indicates flow direction. Photograph collected April 24, 2025.**

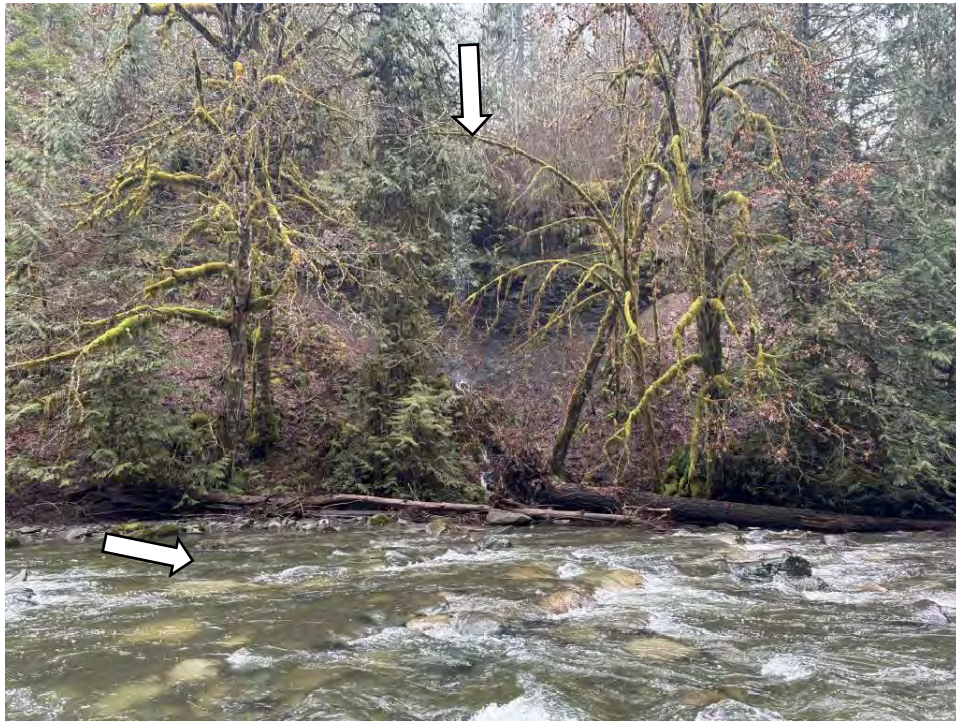
**Photo 37. River left tributary falls (~10 m high) downstream of the Trent River falls. Arrows indicate flow direction. Photograph collected March 10, 2025.**

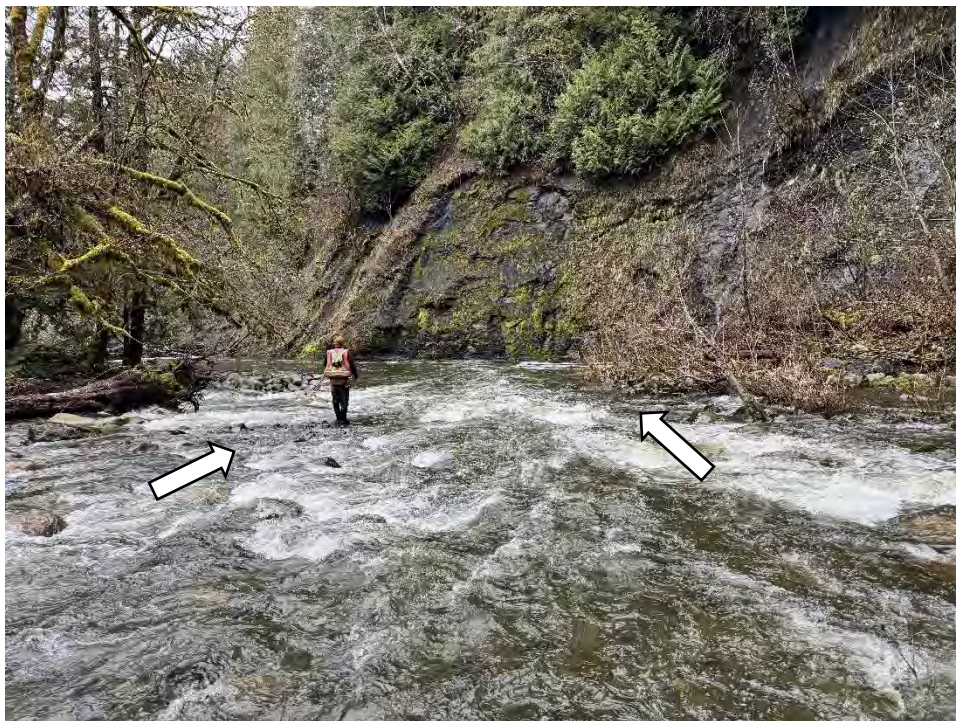
**Photo 38. Confluence of Bloedel Creek (river-right) and the Trent River mainstem (river-left). Arrows indicate flow direction. Photograph collected March 10, 2025.**

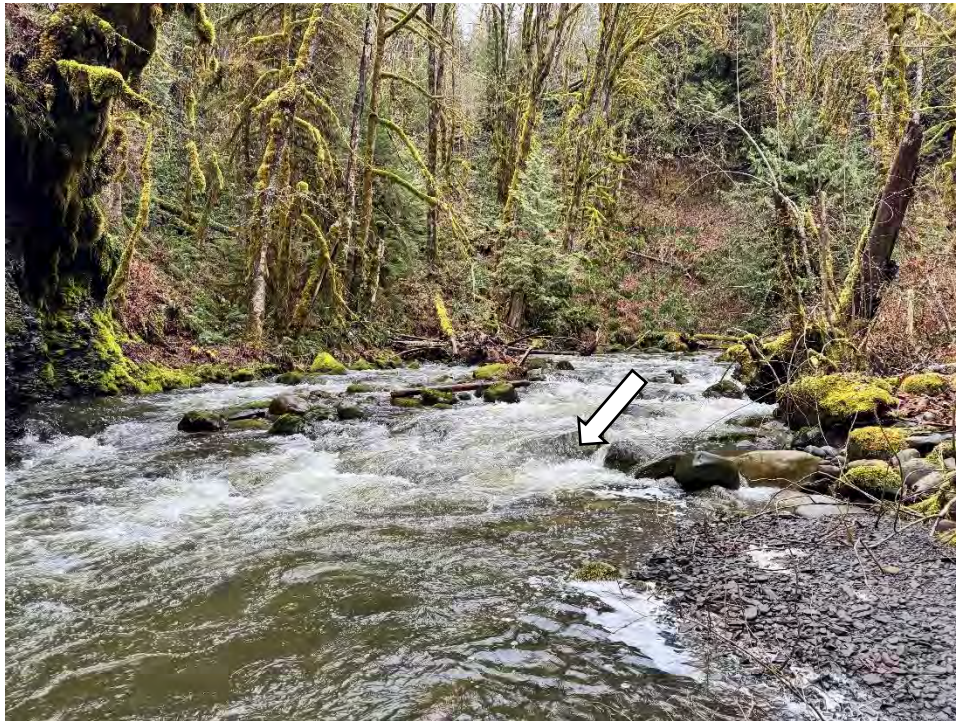
**Photo 39. View upstream of Bloedel Creek near the confluence with the Trent River mainstem. Arrow indicates flow direction. Photograph collected March 10, 2025.**

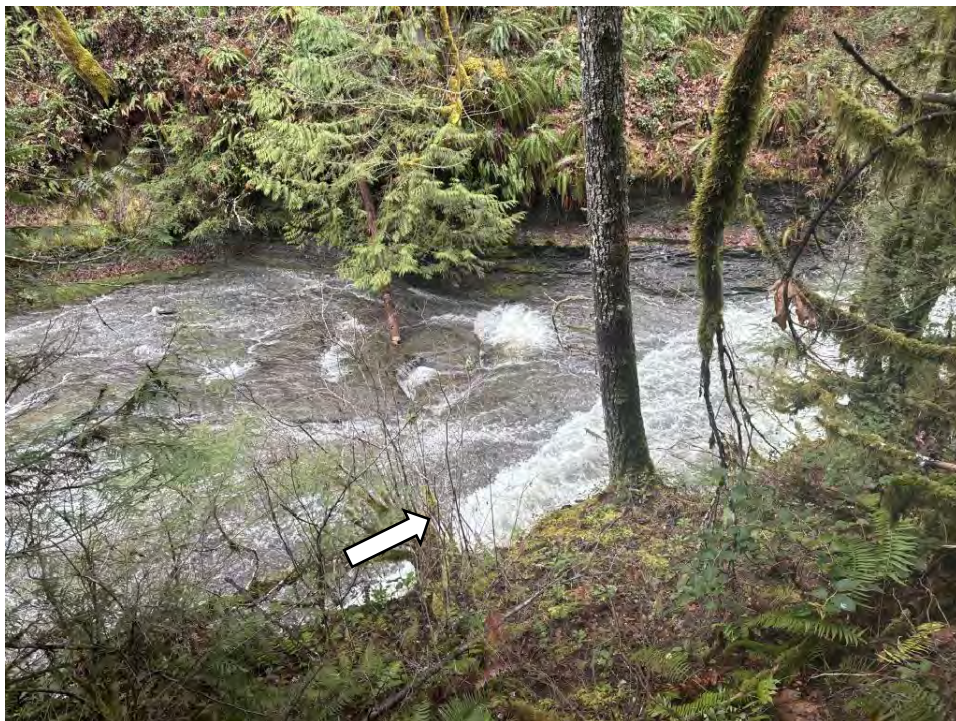
- Trent River Falls: A steep falls section beginning approximately 1 km east from Hwy 19 (see Photo 31, Appendix A);
- Bloedel Creek Falls: An extended bedrock chute followed by a steep falls section, beginning ~200 m east from Hwy 19 and extending for ~600 m downstream (see Photos 40-44, Appendix A);
- Maple Creek Falls: A short bedrock chute and steep falls section ~400 m upstream from the confluence with the Trent River mainstem (see Photos 47-48, Appendix A).

**Photo 40. View of the bedrock chute upstream of the Bloedel Creek Falls. Arrow indicates flow direction. Photograph collected March 10, 2025.**

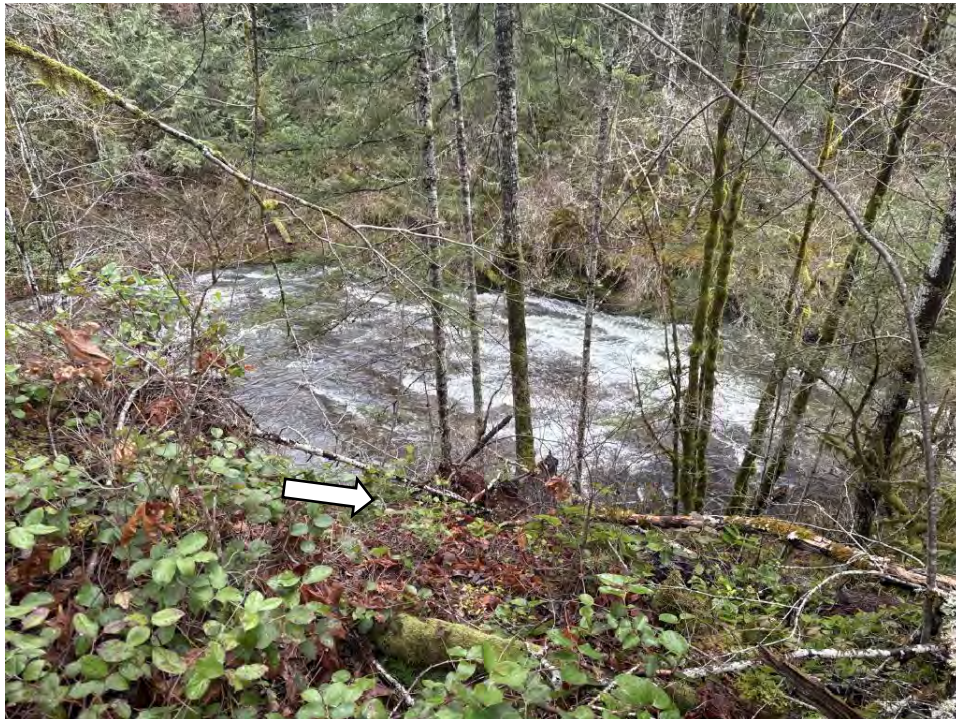
**Photo 41. View of a second bedrock chute upstream of the Bloedel Creek Falls. Arrow indicates flow direction. Photograph collected March 10, 2025.**

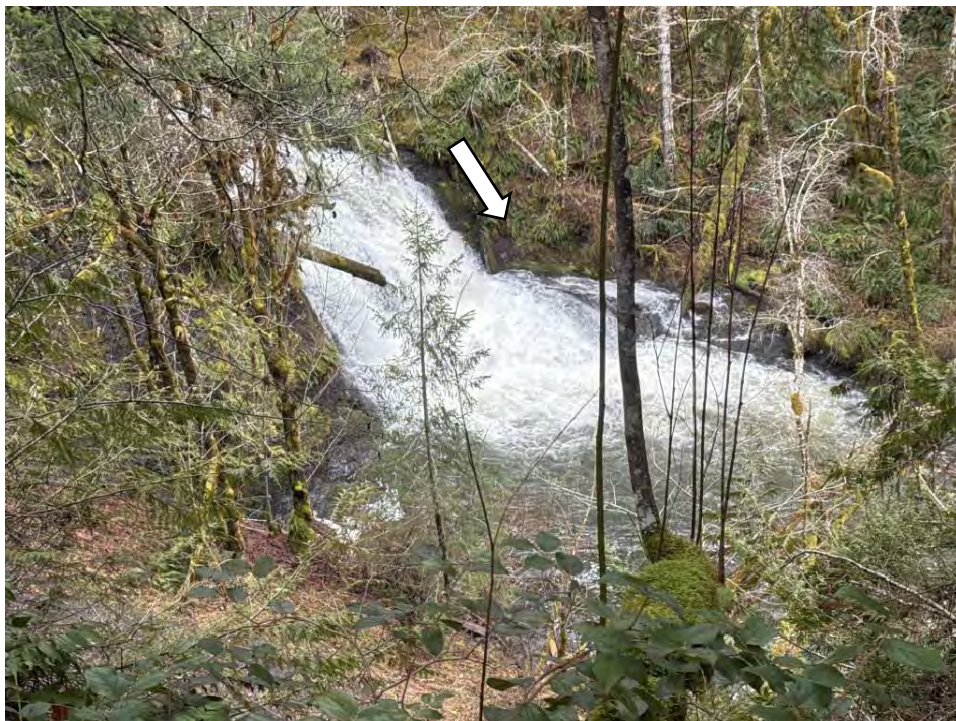
**Photo 42. Bloedel Creek Falls 1. There is a second set of falls ~50 m downstream. Arrow indicates flow direction. Photograph collected March 10, 2025.**

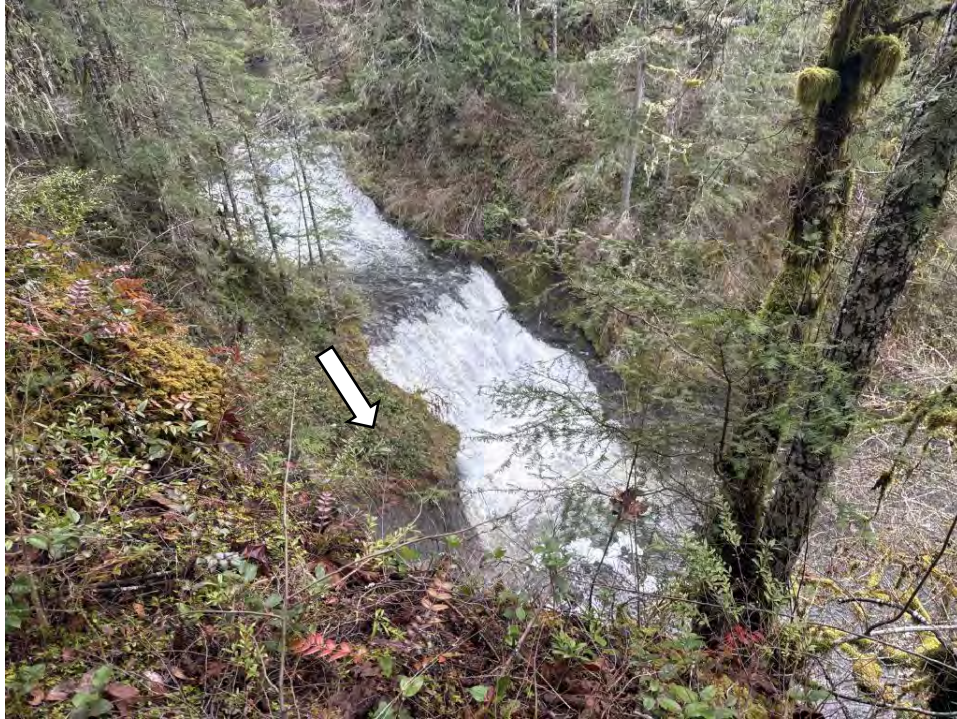
**Photo 43. Bloedel Creek Falls 2. Arrow indicates flow direction. Photograph collected March 10, 2025.**

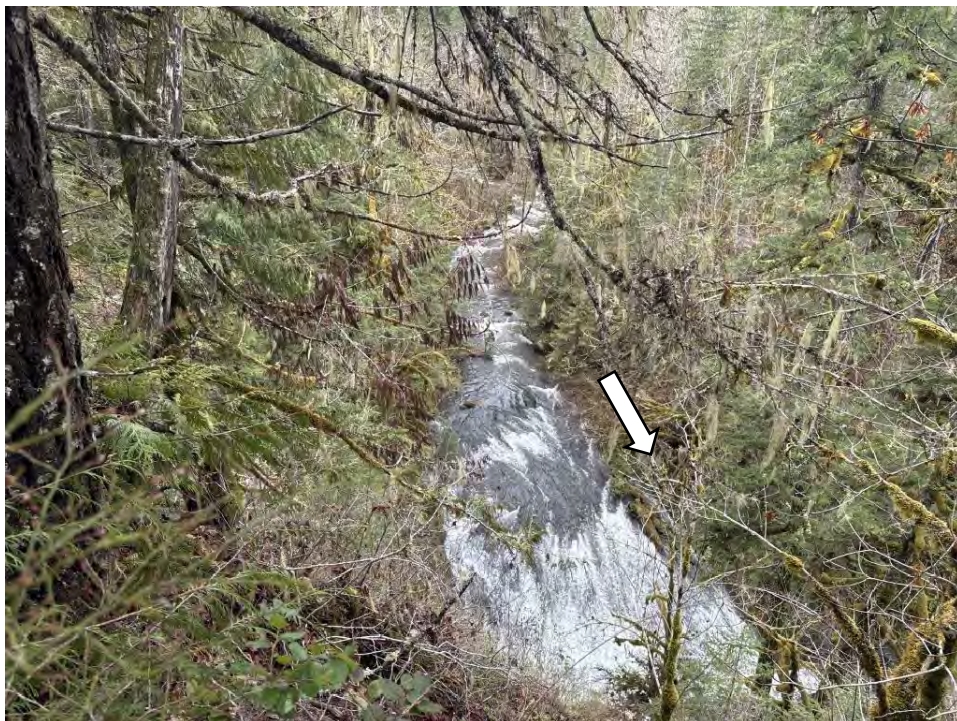
**Photo 44. View of a third bedrock chute downstream of the Bloedel Creek Falls. Arrow indicates flow direction. Photograph collected March 10, 2025.**

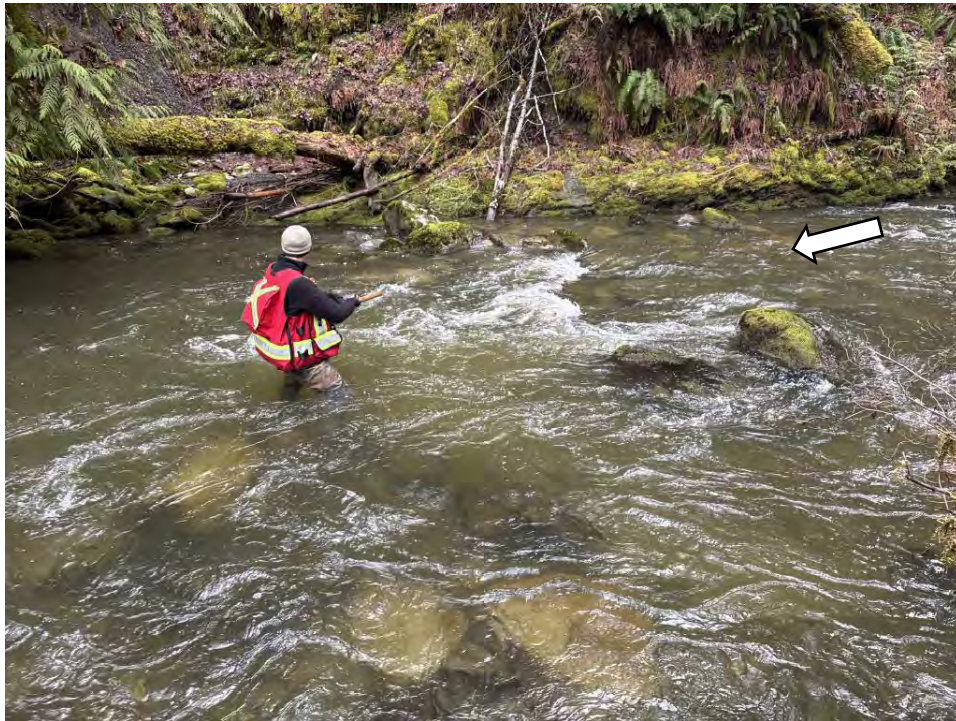
**Photo 45. Representative view of Bloedel Creek habitat downstream of falls/chutes. Arrow indicates flow direction. Photograph collected March 10, 2025.**

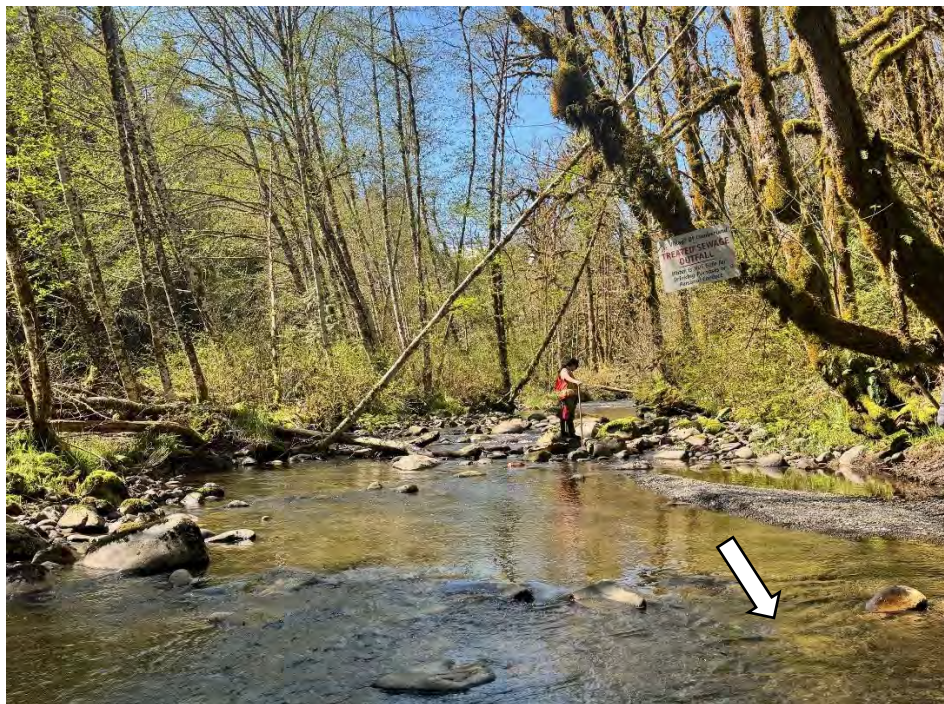
- The historically mapped location of the confluence with the Trent River mainstem was off by ~200 m (see Photo 46, Appendix A).
- In addition, the recorded course of the creek in the vicinity of the large beaver pond was found to be inaccurate.

**Photo 46. Maple Creek confluence with the Trent River mainstem. Arrow indicates flow direction. Photograph collected April 22, 2025.**

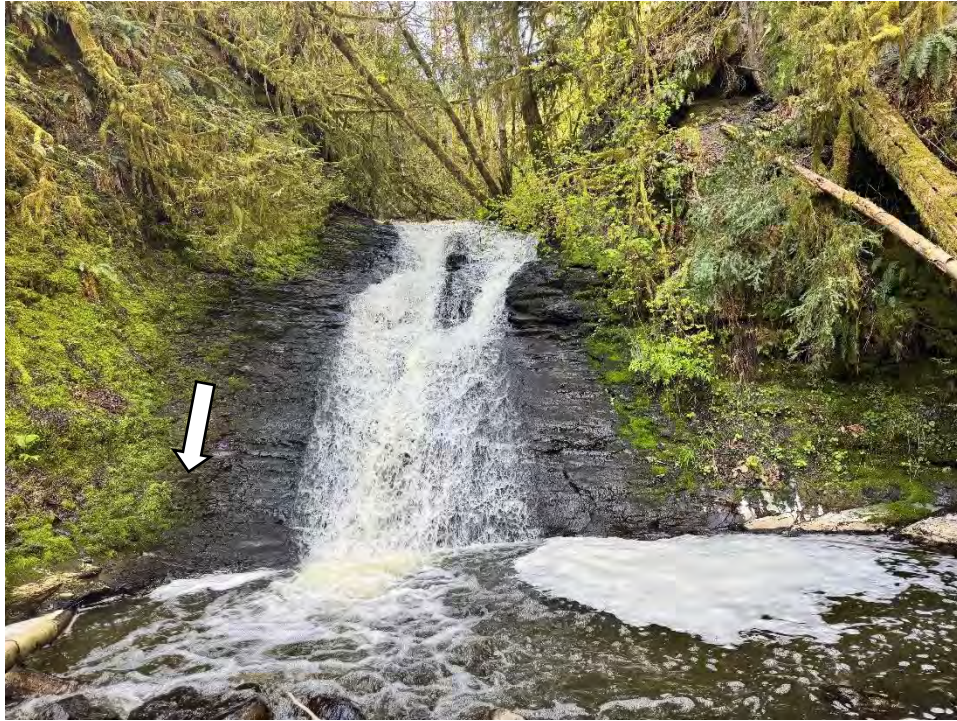
**Photo 47. Maple Creek falls. Arrow indicates flow direction. Photograph collected April 22, 2025.**

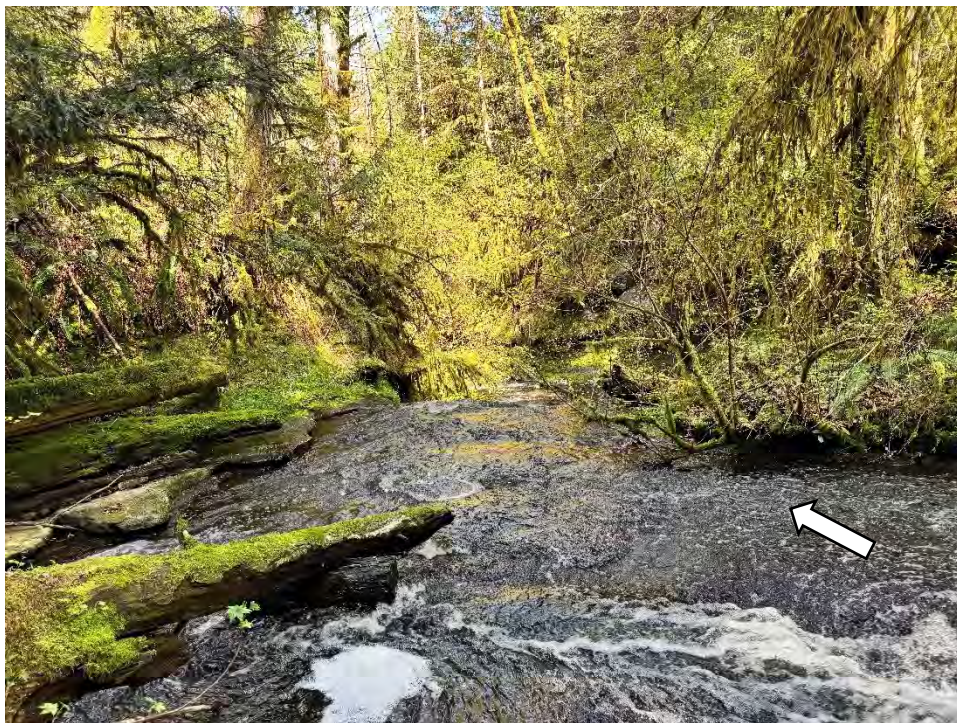
**Photo 48. Start of bedrock chute above Maple Creek falls. Arrow indicates flow direction. Photograph collected April 23, 2025.**

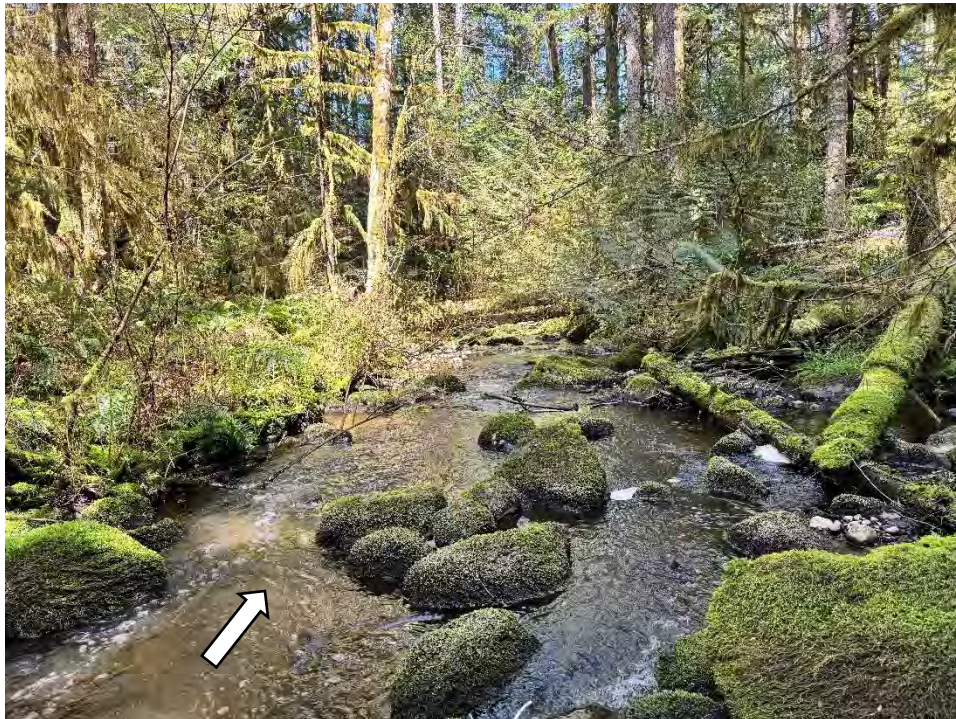
Maple Creek currently serves as the sewage outfall for the Village of Cumberland. During the survey, increased algae growth and brown, turbid water was observed within Maple Creek and the Trent River mainstem downstream of the Maple Creek confluence —conditions consistent with nutrient enrichment or effluent discharge impacts. However, Coho fry were still observed in the lower reaches below the Maple Creek Falls (April 22, 2025). The combination of sewage effluent, reduced water clarity, and potential eutrophication poses concerns for overall water quality and the suitability of Maple Creek as habitat for Pacific salmon. See the Summer Low-Flow Assessment Section below for further discussion.

**Photo 49. Representative view of Maple Creek above falls. Note the abundance of algae and moss on the boulders. Arrow indicates flow direction. Photograph collected April 23, 2025.**

- **Water Quality Monitoring and Fish Sampling:** Collection of water samples for fecal coliform, nitrogen, and phosphorus testing is encouraged, as these parameters are key indicators of eutrophication. In addition, fish inventory sampling (e.g., minnow trapping or electrofishing) above the Maple Creek Falls is recommended to assess fish habitat quality for resident fish (i.e., cutthroat trout).

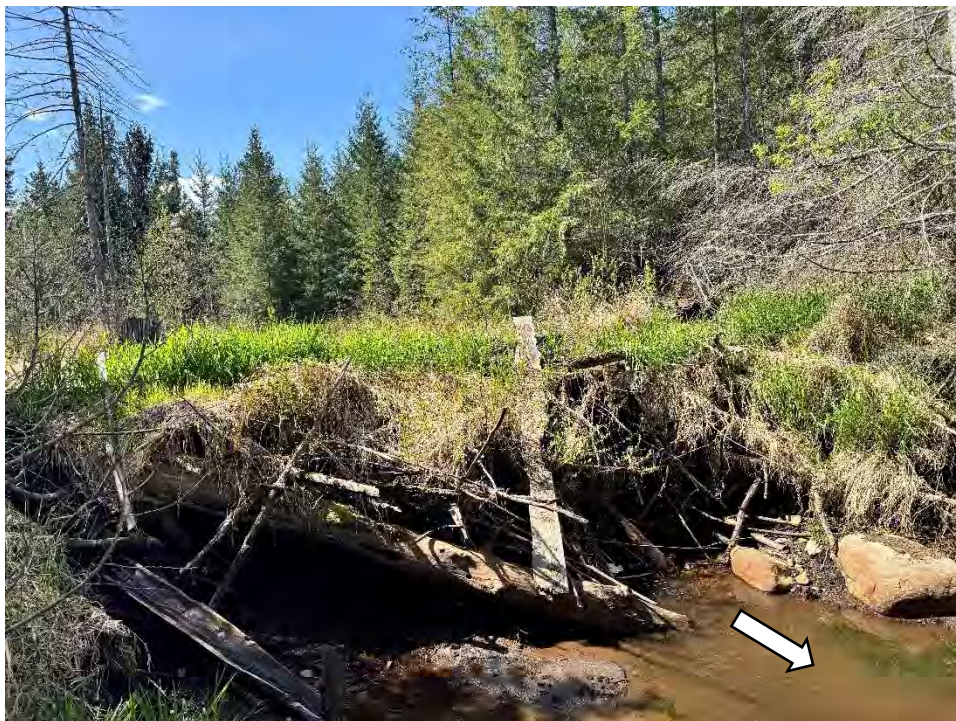
**Photo 51. View of the beaver pond sourcing the river-right tributary of Maple Creek. Photograph collected April 23, 2025.**

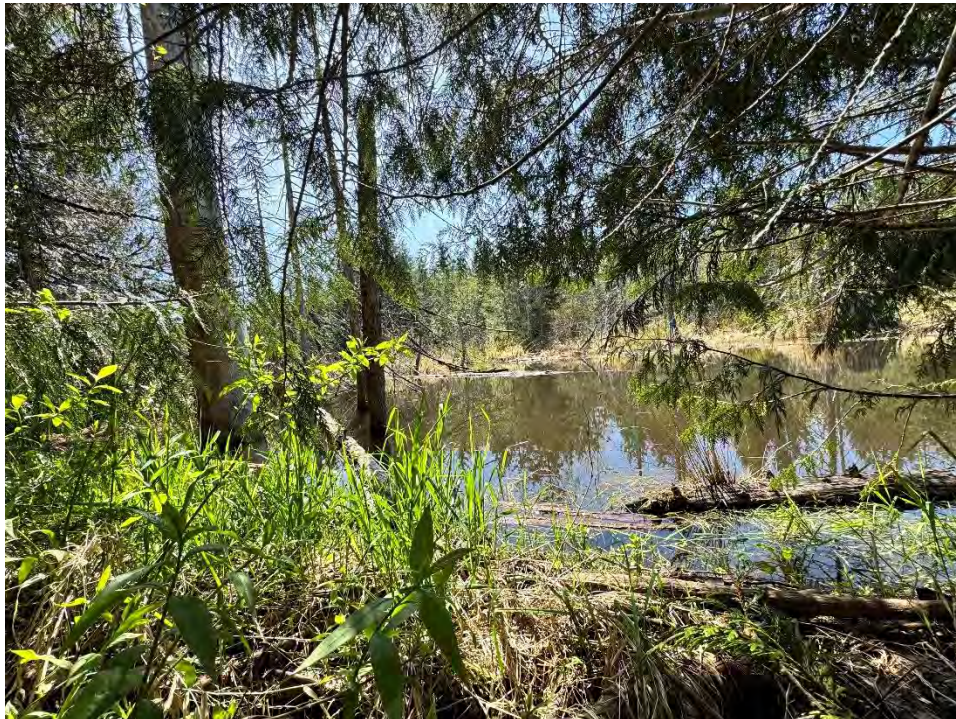
Between the service road crossing and the Maple Creek falls, the stream channel becomes heavily impacted by a dense infestation of reed canary grass (*Phalaris arundinacea*). This invasive grass forms dense monocultures that outcompetes native riparian vegetation, reduces plant diversity, alters stream-bank stability, restricts water flow, and degrades fish habitat. In this context, the reed canary grass infestation reduces habitat quality for native fish species (i.e., resident cutthroat trout), by increasing water temperatures due to loss of shading vegetation, disrupting natural channel processes, promoting sedimentation, and reducing the quality of spawning gravel and rearing habitat. See Appendix A (Photos 51-52) for representative photos.

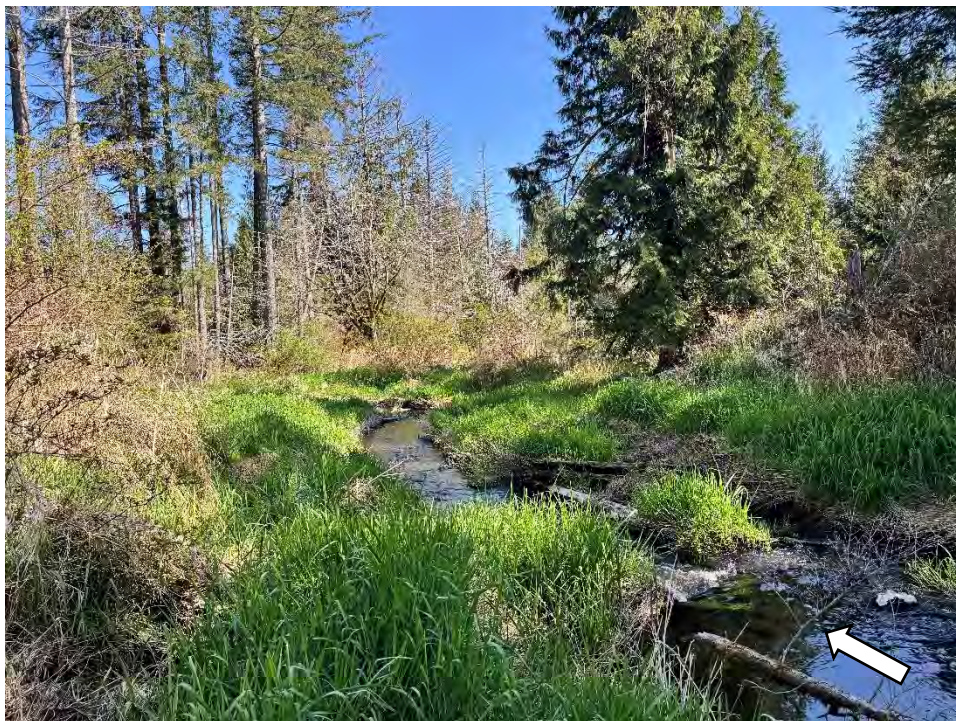
**Photo 52. Representative view of Maple Creek near the forest service road. Note the abundance of reed canary grass in the channel. Arrow indicates flow direction. Photograph collected April 23, 2025.**

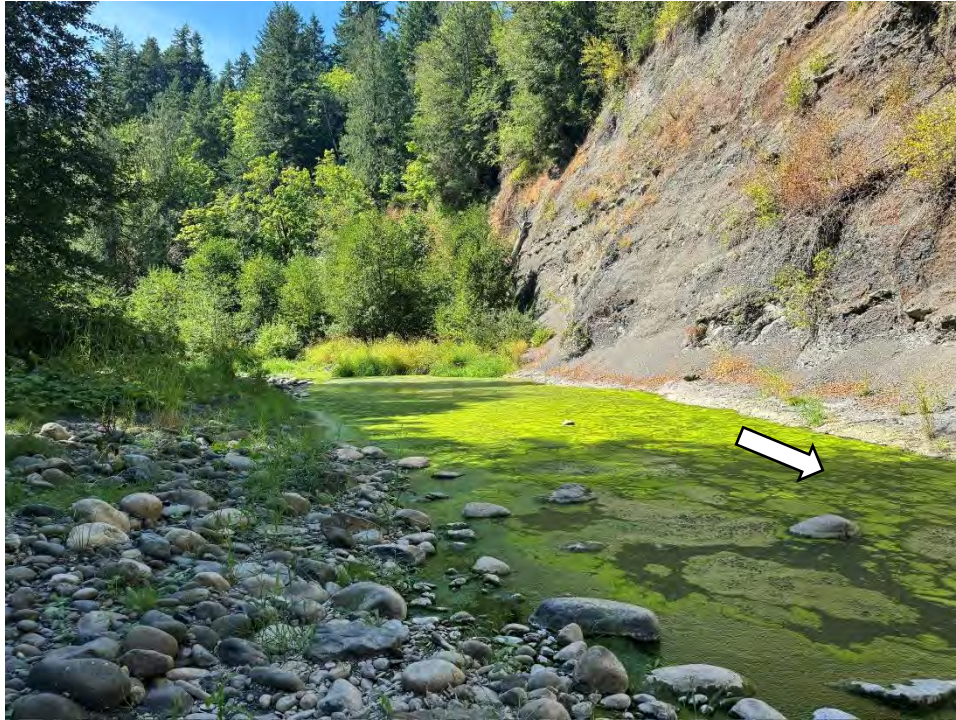
During the low-flow assessment, water quality conditions within the Trent River mainstem downstream of the Maple Creek confluence were observed to be brown, turbid, and warm (>15 °C). Substantial algal growth was present on the streambed and floating within pools. Fish (i.e., coho fry, three spined sticklebacks) were observed in this reach; however, incidental observations of coho fry ceased approximately 2.6 km downstream of the Maple Creek confluence, while incidental observations of three spined stickleback continued. In comparison to coho salmon, three spined sticklebacks are more tolerant to increased water temperature and decreased dissolved oxygen concentrations. In contrast, water clarity improved and algal abundance decreased to negligible levels upstream of the Maple Creek confluence (See Photos 53-54, Appendix A).

**Photo 53. Representative view of the Trent River mainstem below the Maple Creek confluence observed during the summer low-flow assessment. Arrow indicates flow direction. Photograph collected August 21, 2025.**

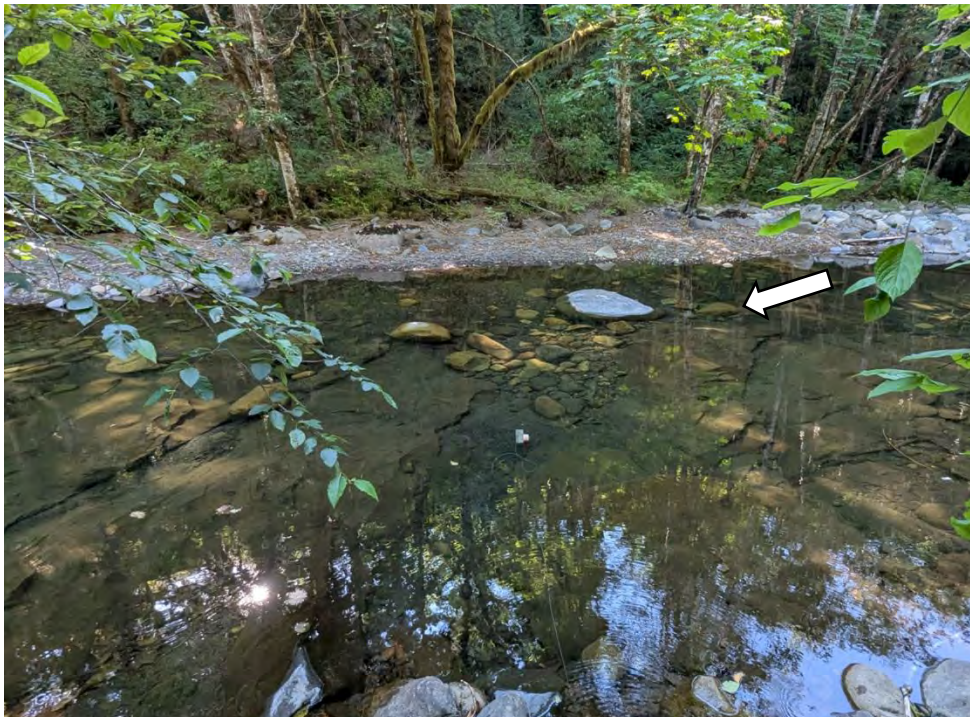
**Photo 54. Representative view of the Trent River mainstem upstream of the Maple Creek confluence. Arrow indicates flow direction. Photograph collected August 25, 2025.**
