# Beaufort Watershed Stewards - 2021

## Hydrological Health Report Card on Four Watersheds

Nov. 4, 2021

by Dave Weaver - Retired Professional Forester  
Vice President Beaufort Watershed Stewards

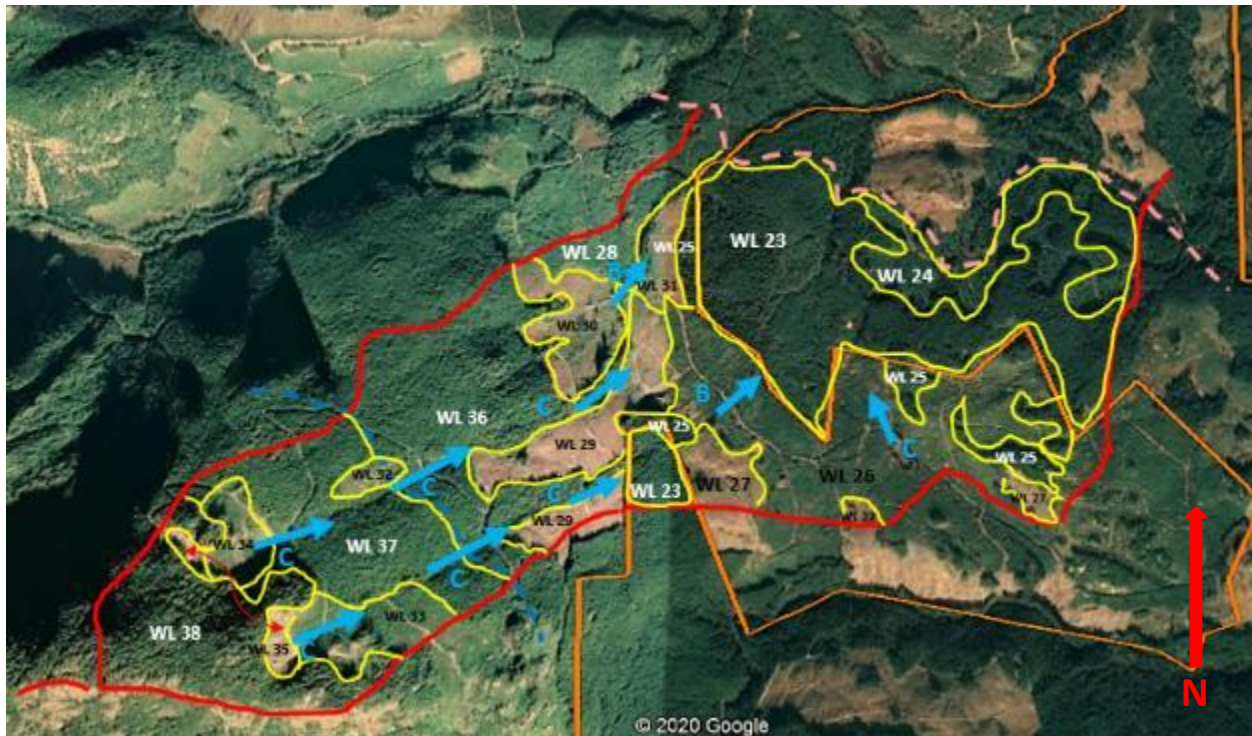
**Figure 7:** Waterloo Creek Disturbance Unit Map Transition and Snow Zone – Example Map

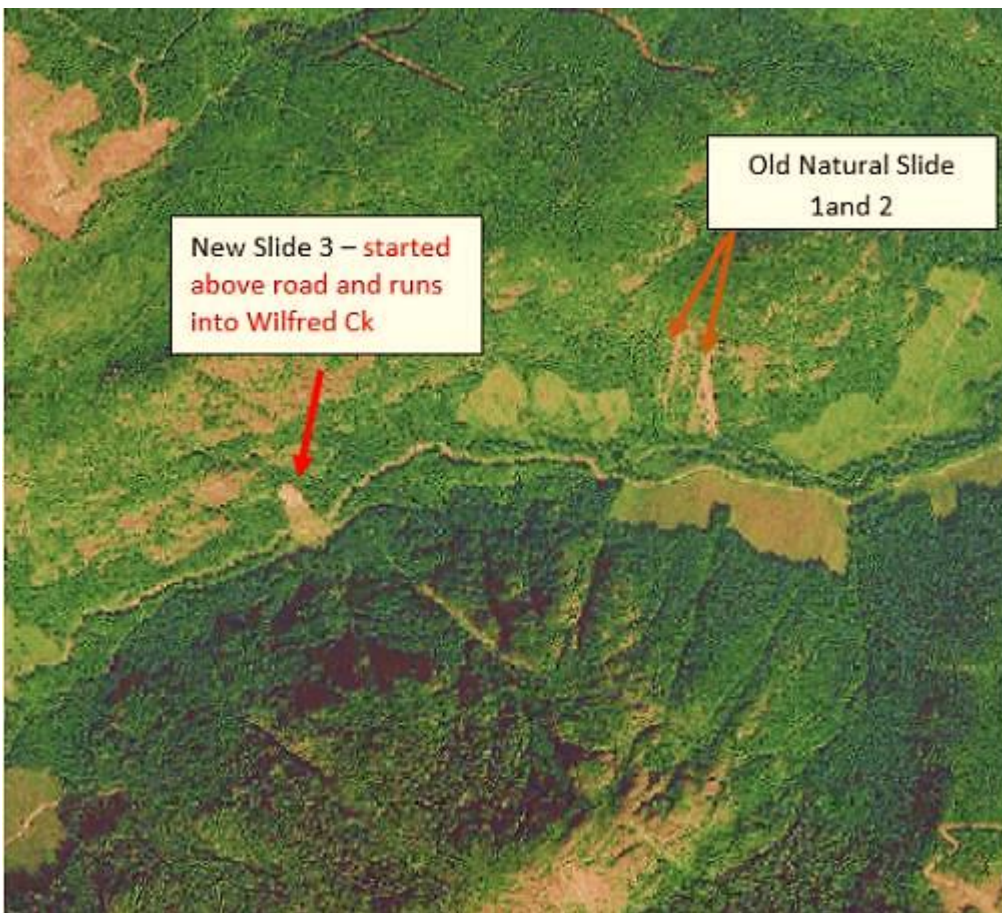
**Photo 2:** Location of slides from Landsat Image Sept 2017

\*\*The following are photos of natural landslides – two identified outside productive forest land in rock bluff terrain and one newer one (circa 2017) above a constructed road in productive forest. Several other slide disturbances were observed on satellite images, but these appear to be avalanche tracks at a very high elevation on steep subalpine slopes. This tree cover removal and resultant exposed parent materials appear more likely due to snow avalanches.

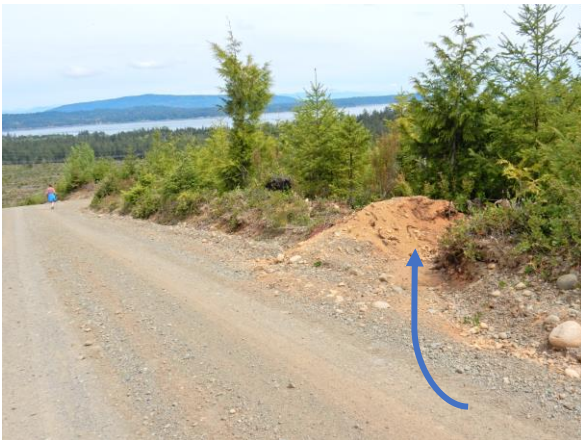
| Road Aspects Observed | Private Forest Roads | Public Forest Roads |
|---|---|---|
| Road side sediment runoff measures | <ul style="list-style-type: none"> <li>• Long steep stretches of active roads all had side <i>diversions drains</i> regularly graded into the side cast (see Photo 7 below)</li> </ul> | <ul style="list-style-type: none"> <li>• Very few if not any observed <i>diversions drains</i> graded into the side cast.</li> </ul> |

**Photo 7:** Example of good road maintenance practice in making *diversions drains* graded into the side cast, on private roads – Hastings Main.
